Long Eaton Aerial Survey 12 September 2017

Aerial Roof Survey

Aerial Roof Survey – Job Number 42669

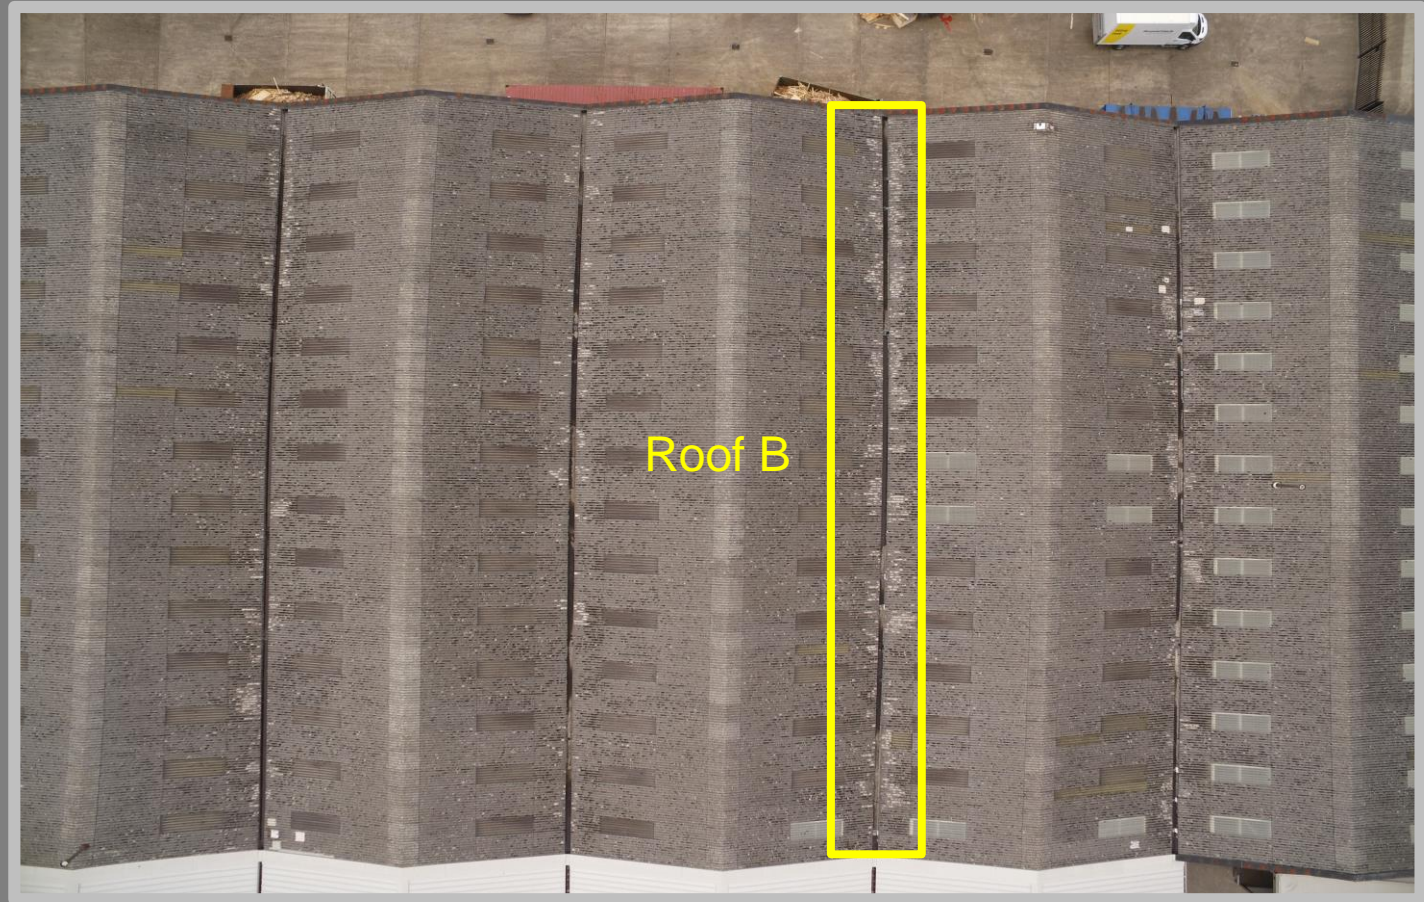
This aerial shot shows the roof of Warehouse B.

Delamination

From this expansive roof shot in the bottom of the valley gutters you can observe light grey patches indicating delamination.

This problem occurs over a long period of time. In some cases, its down to a faulty batch. Once signs of delamination occur then rapid repair is essential.

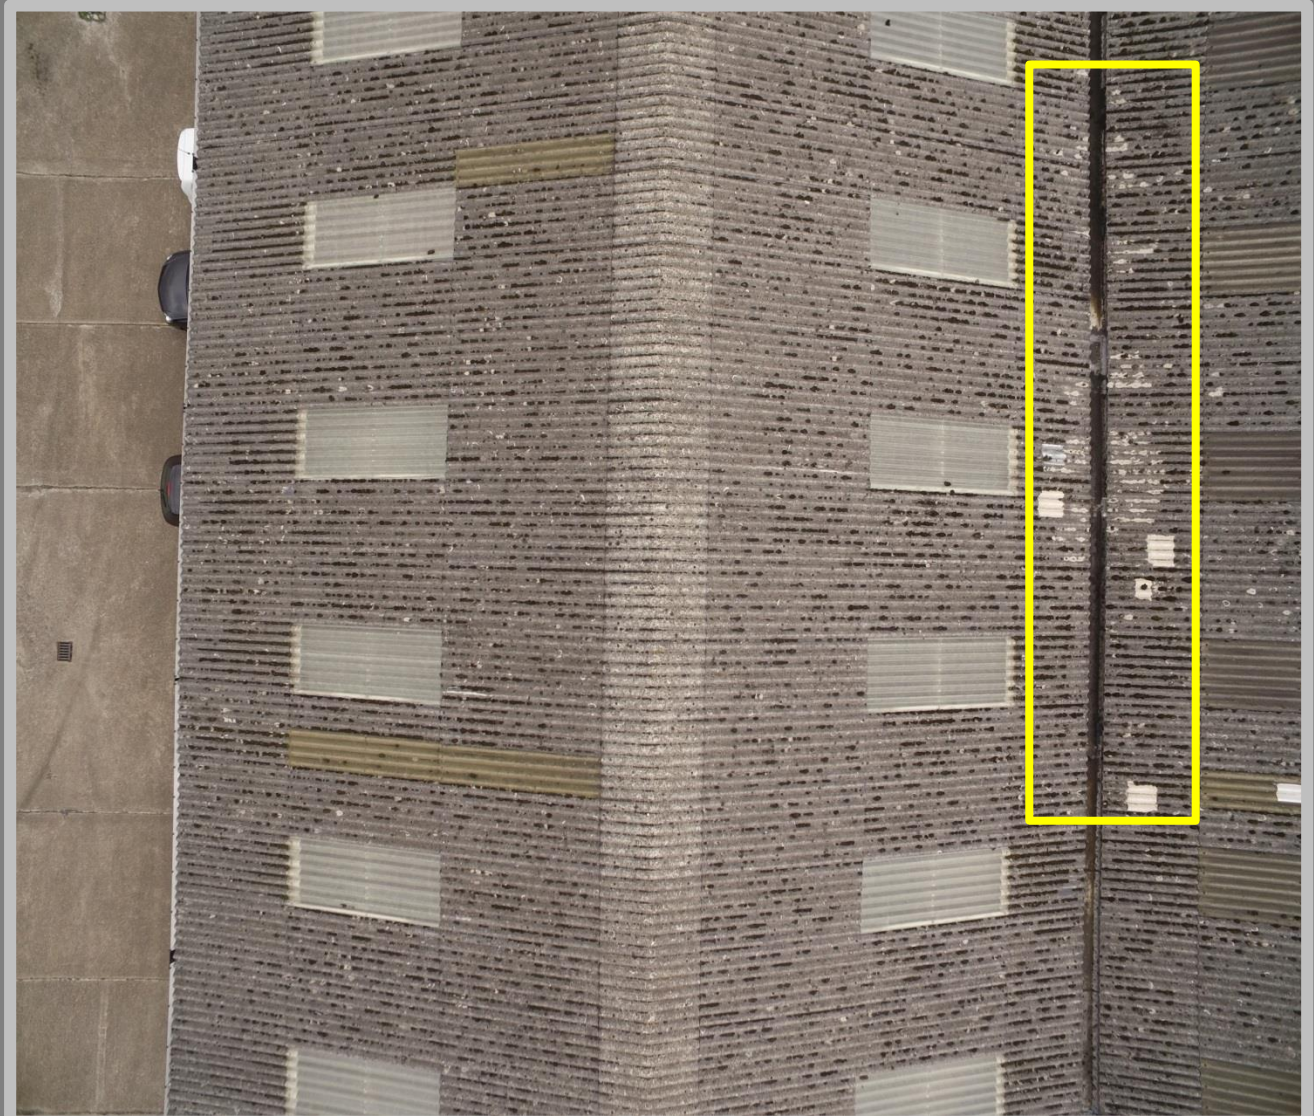
This aerial shot shows the roof of Warehouse B.

Delamination

From this shot in the bottom of the valley gutters you can observe delamination and see a number of patches. Delamination makes the asbestos very porous and brittle making it susceptible to leaks and cracks. These patches clearly indicate this is happening.

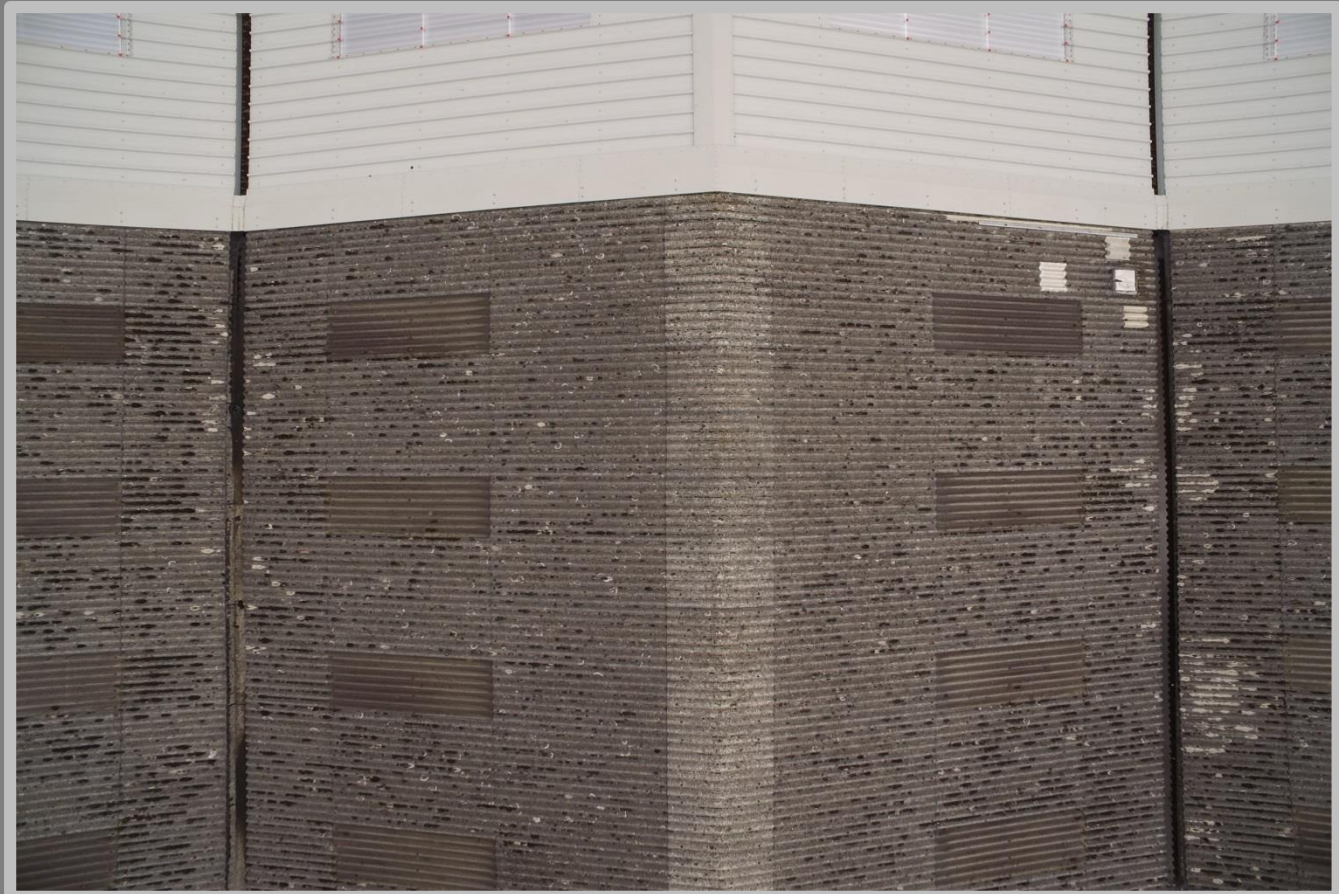
This aerial shot shows the roof of Warehouse B where it joins the new roof.

This shot shows the joining of the new roof to the asbestos roof. The roofing contractors have done a good job in joining the two roofs.

The vulnerability of these joined roofs is the asbestos roof. It is apparent by the number of patches how porous and vulnerable the roof is in the valley bottoms.

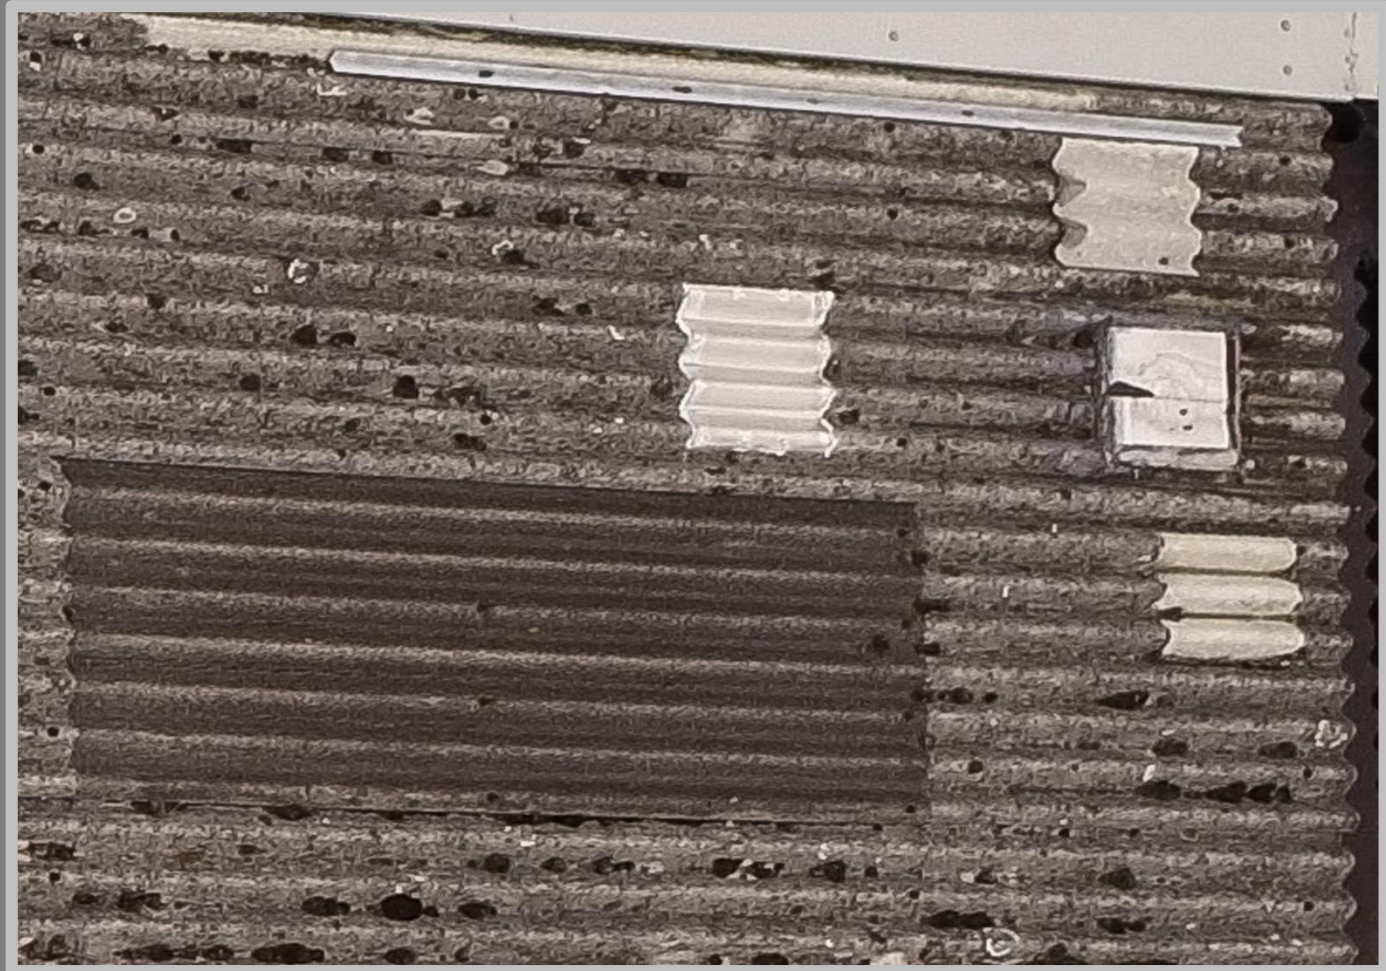
Existing Repairs

This close-up from the previous photo shows the patches very close to the new roof.

When a roof needs extensive patching like this it is a very clear indication of the overall condition of the roof. A patch is a short term measure to stop a leak. A patch is not a problem permanently solved because the sealants eventually fail and then start leaking again.

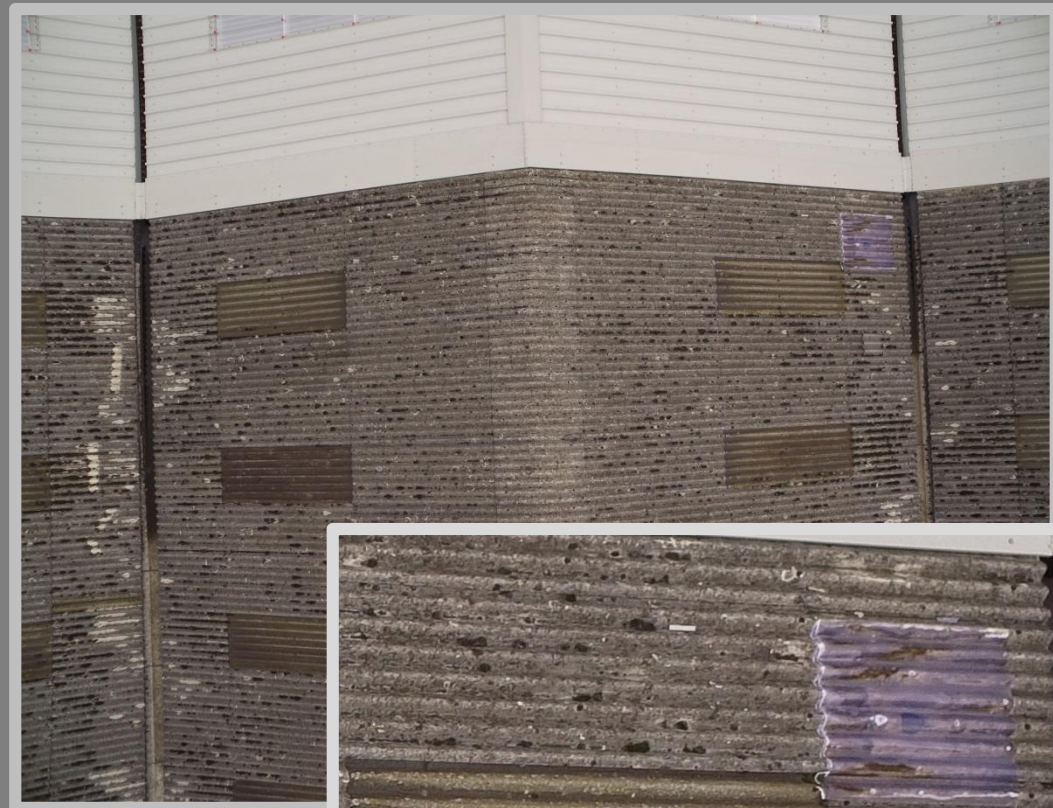
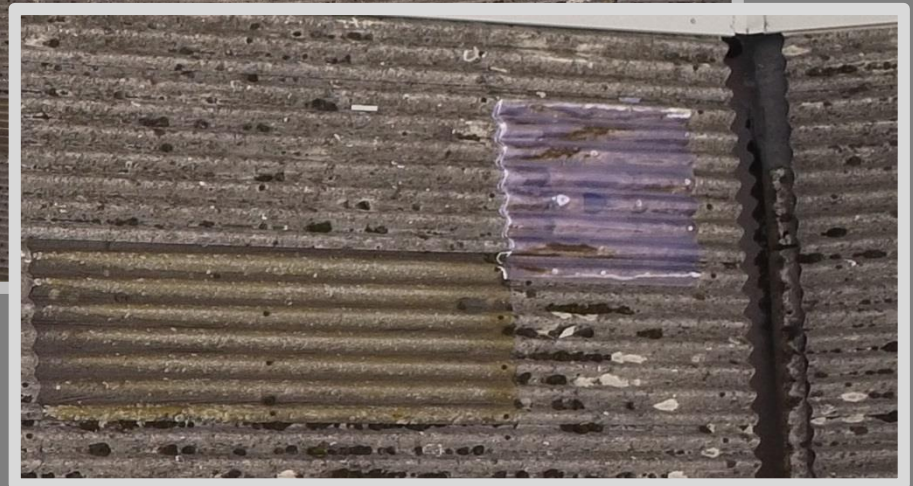
Existing Repairs

This shot shows another larger patch close to the new roof. The close-up photo shows the patch is covering a significant hole and crack in the roof.

Roof-Lights – GRP

Roof B is comprised of 9 pitched roofs each pitched roof has 28 roof-lights. Roof B has a total of 252 roof-lights.

This shot shows the general condition of all the roof-lights. UV light causes the roof-lights top resin coating and the sealant to degrade. Moss will also grow up and under the roof-lights allowing water to enter past the degraded sealant via capillary action. All the roof-lights were also examined for damage.

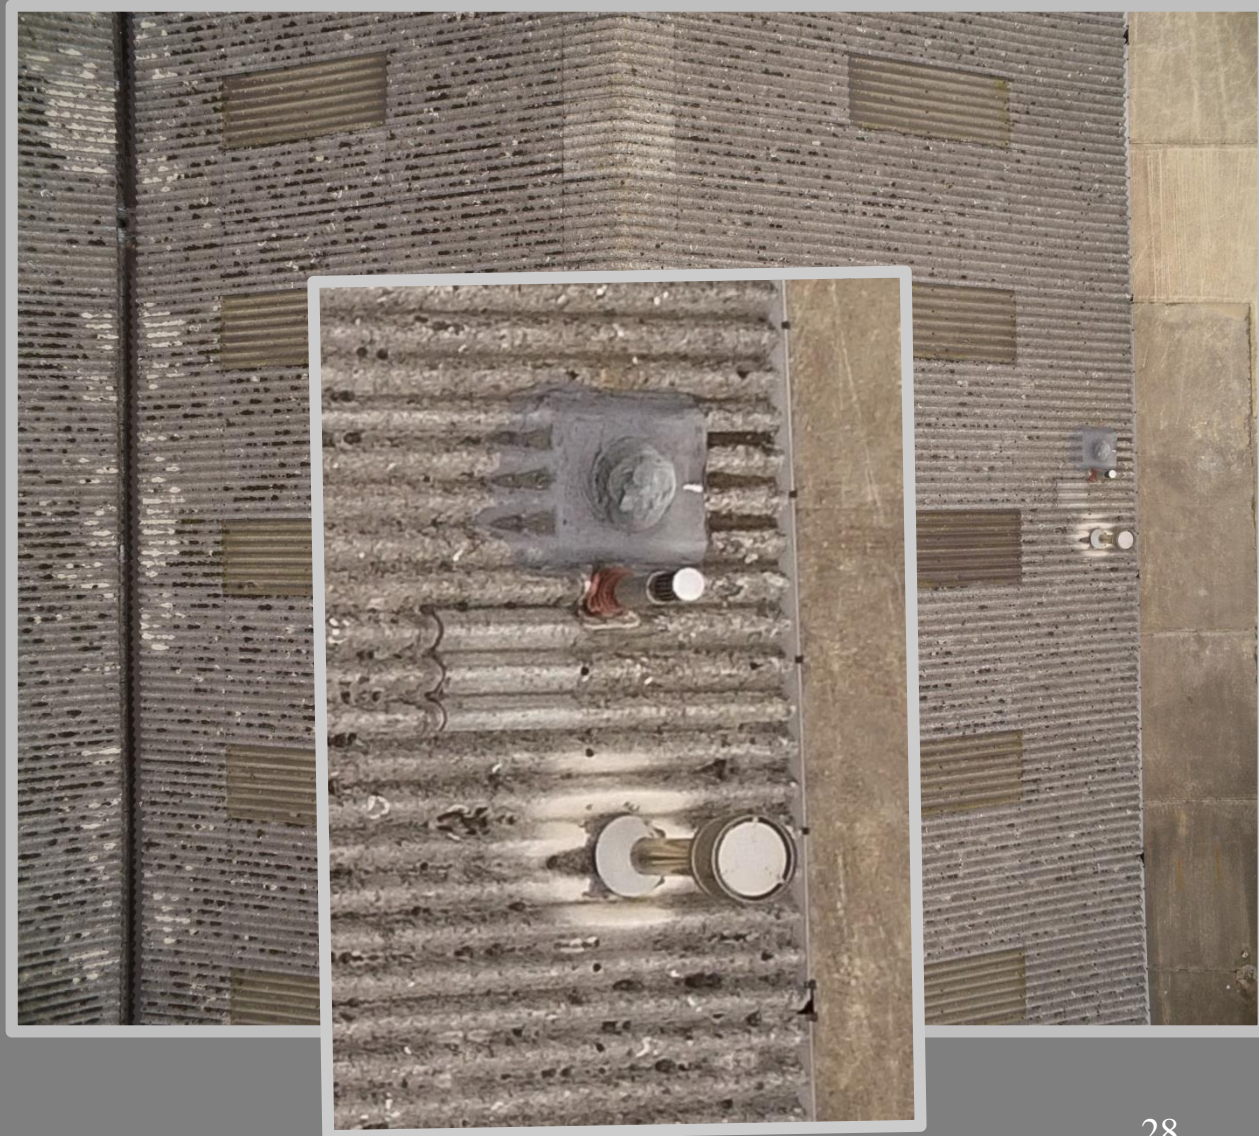
Ventilation outlets

This shot shows another problem where ventilation outlets have been installed in the roof. The sealants will eventually fail and cause leaking. Roof encapsulation addresses the problem by encapsulating the sealants.

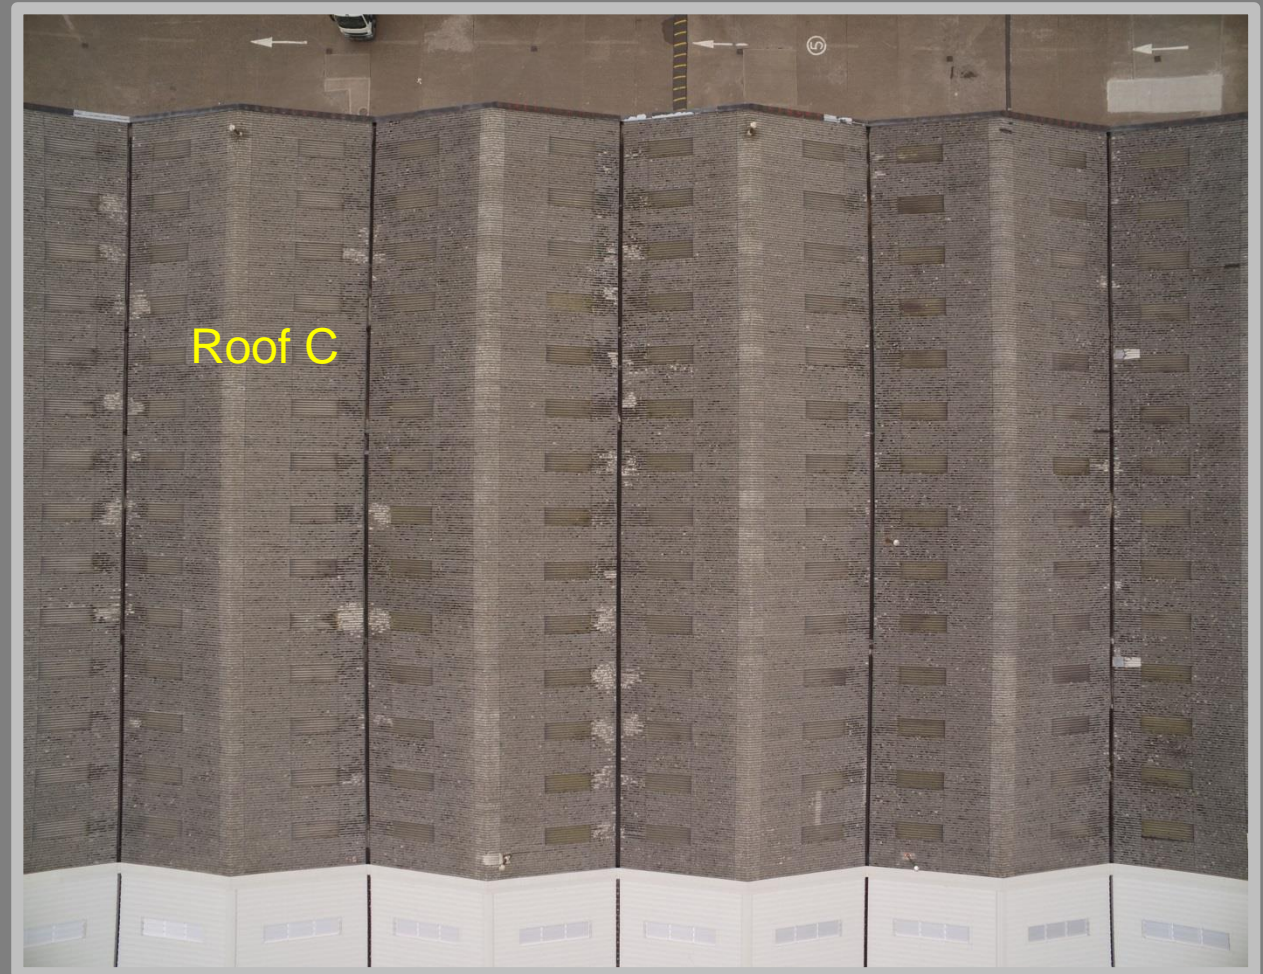
Delamination

From this expansive roof shot in the bottom of the valley gutters you can observe delamination (white patches) which generally occurs over a long period of time.

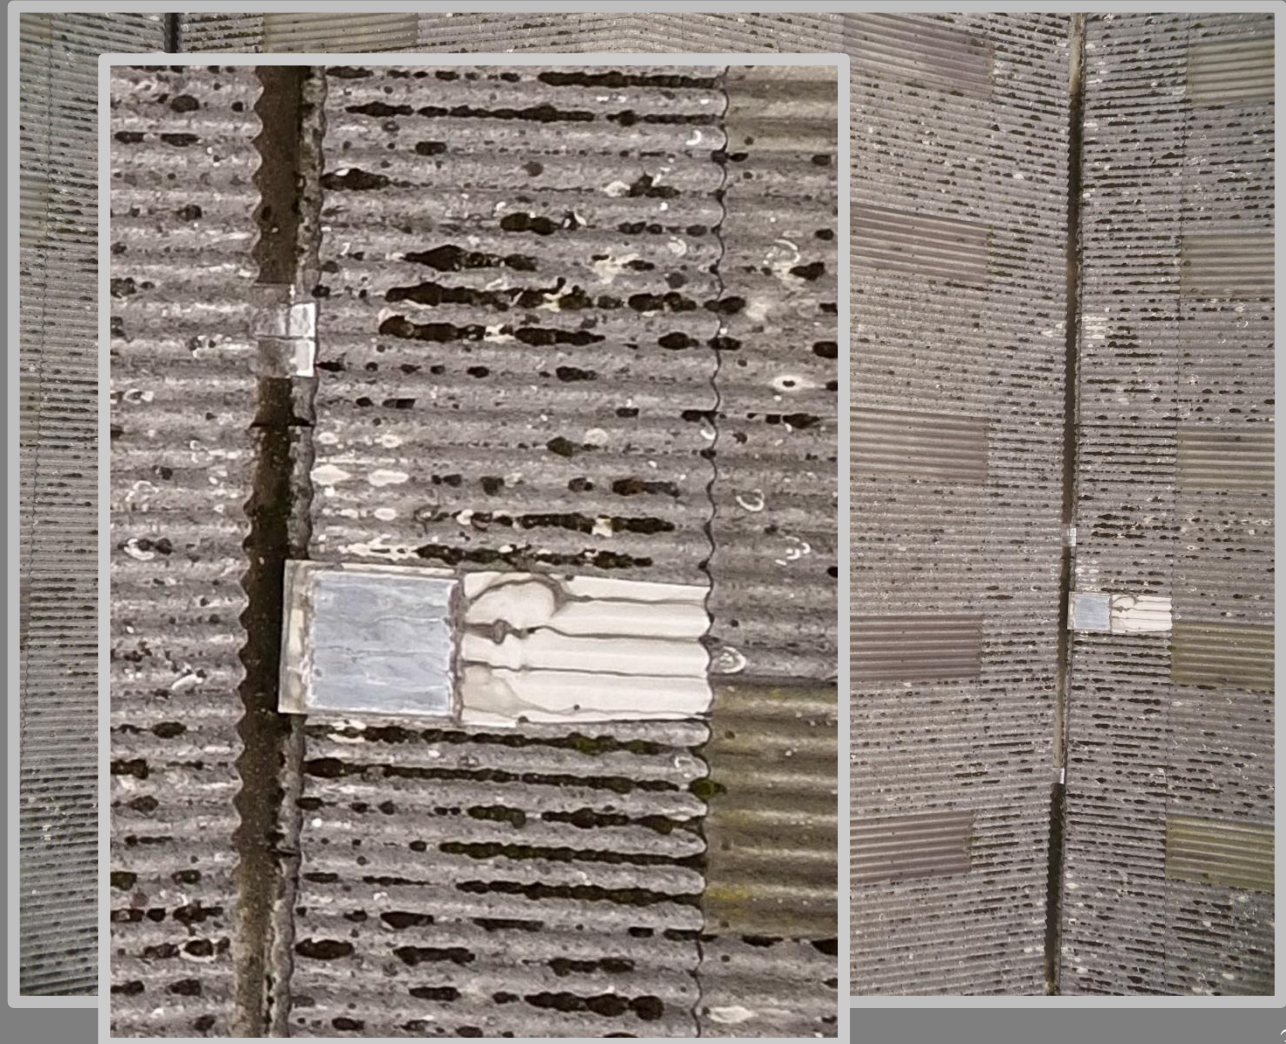
Existing Repairs

This aerial shot shows that roof C has had to have some patches applied to address a leak in the roof.

The close-up photo demonstrates that this patch is not a localised problem but is the result of the overall deterioration of the roof.

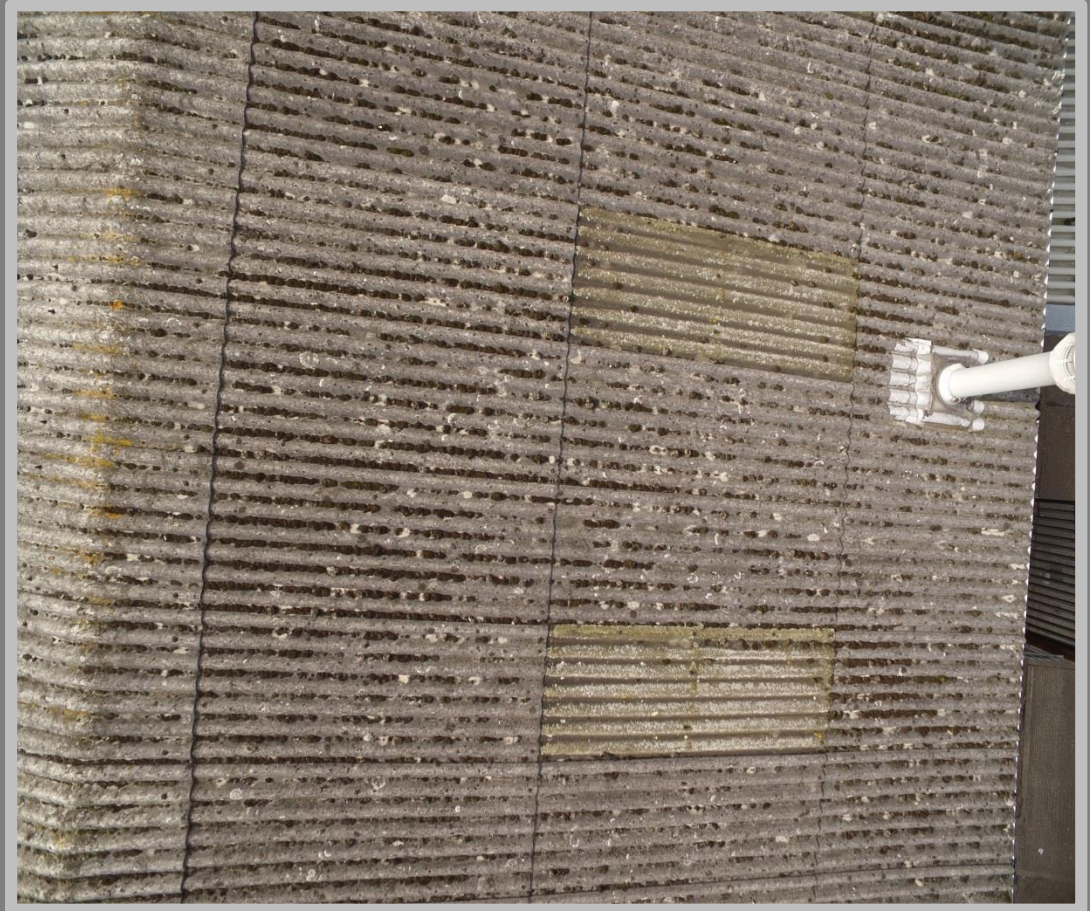
Delamination

This roof shot is typical of the whole roof which shows widespread delamination with moss and lichen.

Because moss or lichens growing on a roof surface will hold moisture longer than other areas, these growths can reduce the life of the roof covering particularly where the roofing materials are of a composite nature like asbestos cement. Holding water on the roof surface by any means speeds up wear of the roof panels. In freezing conditions there may be faster frost damage, cracking, and wear of the roof panels under the moss or lichens. Moss and lichen on roofs also creates roof traction preventing snow from sliding off the roof. Build up of snow on weakened asbestos roofs causes cracking.

Even in non-freezing conditions, the roots or growth structures of moss or lichens eventually penetrate and separate the roof materials, speeding their demise.

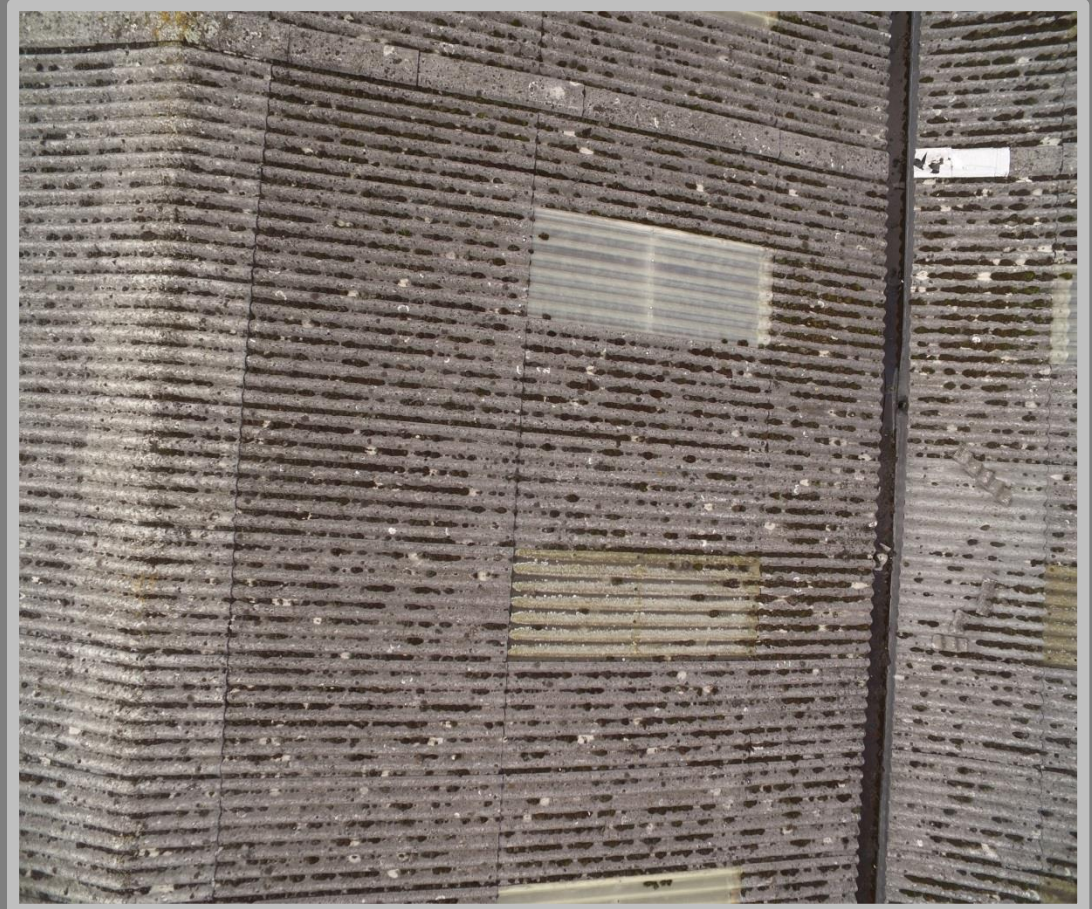
This shot shows some variation in the condition of the roof-lights. One of the roof-lights looks like a recent replacement.

UV light will cause the roof-lights top resin coating and the sealant to degrade. Moss will also grow up and under the roof-lights allow water to enter past the degraded sealant via capillary action.

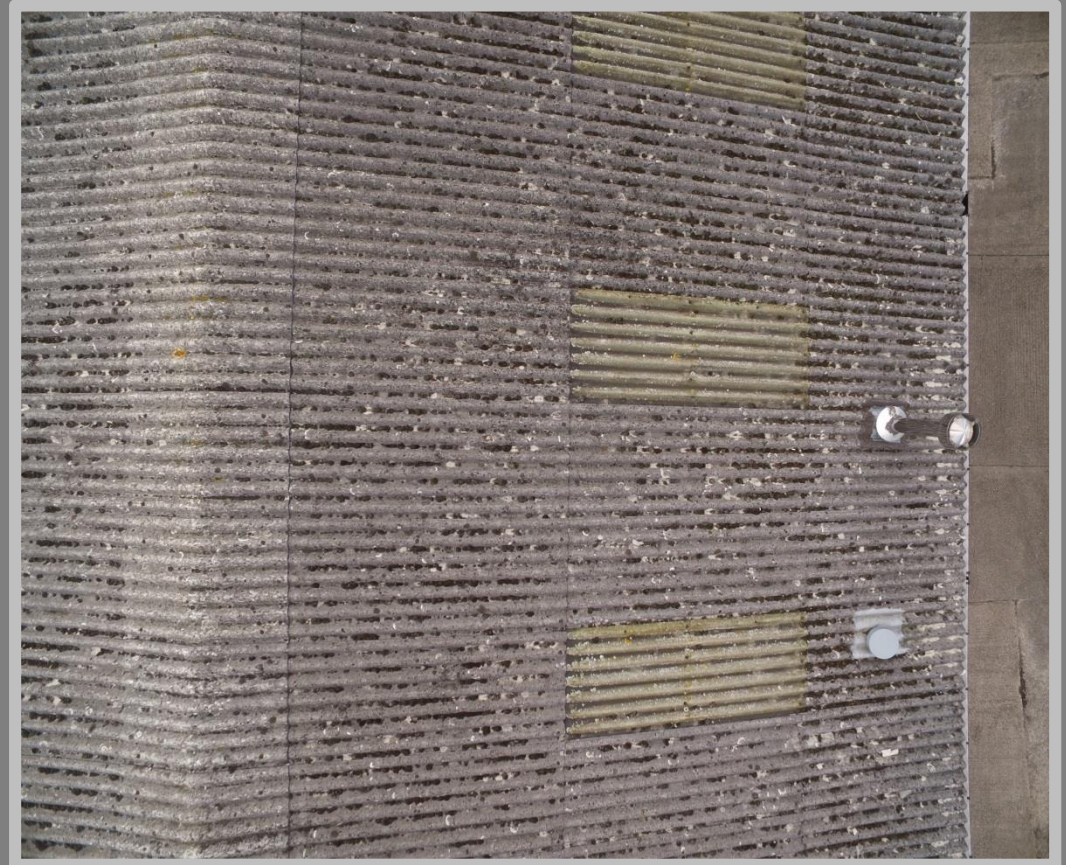
This shot shows the general condition of the Roof-Lights.

The solution would be to either clean the roof - lights and apply a shatter proof top coat and seal the bottom or totally replace the roof-lights. Both are fairly easy and cheap to do.

When repairing roof-lights en masse it is often advisable to replace all or apply the same repair remedy to all otherwise you end up with a roof that is in various stages of wear and repair. This scenario leads to continual unsynchronised roof repairs which is costly both in terms of repair and business interruption.

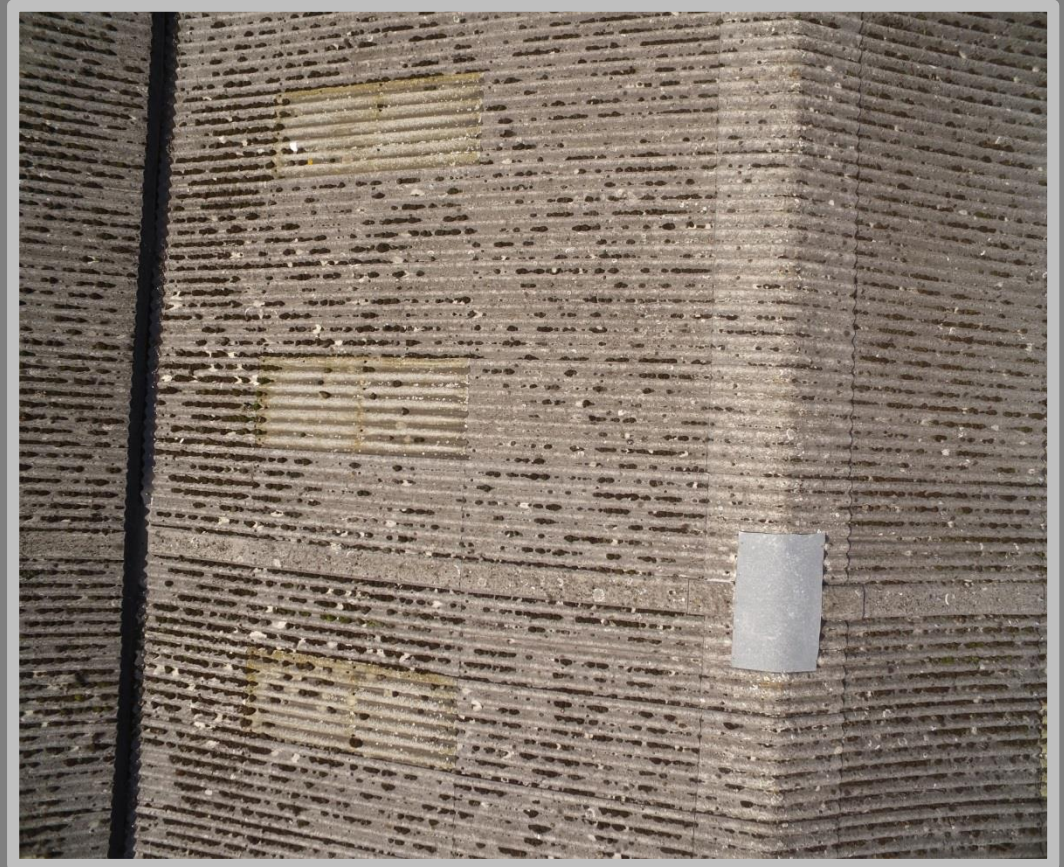
Ridge damage

In this shot there is a roof ridge patch it is difficult to say what caused this damage other than general wear of the asbestos panels.

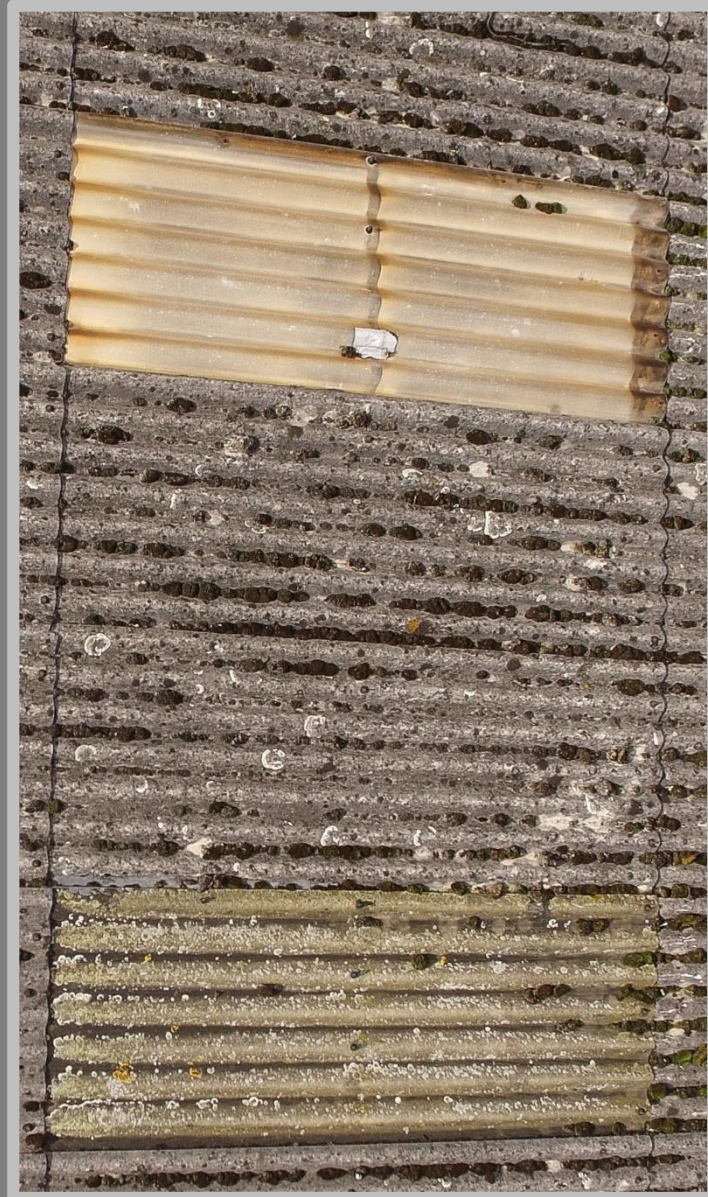
This close up shot of the roof-light clearly demonstrates the variation in their condition. The top roof-light seems to be a recent replacement or repair but the tape patch shows there was a problem with this repair.

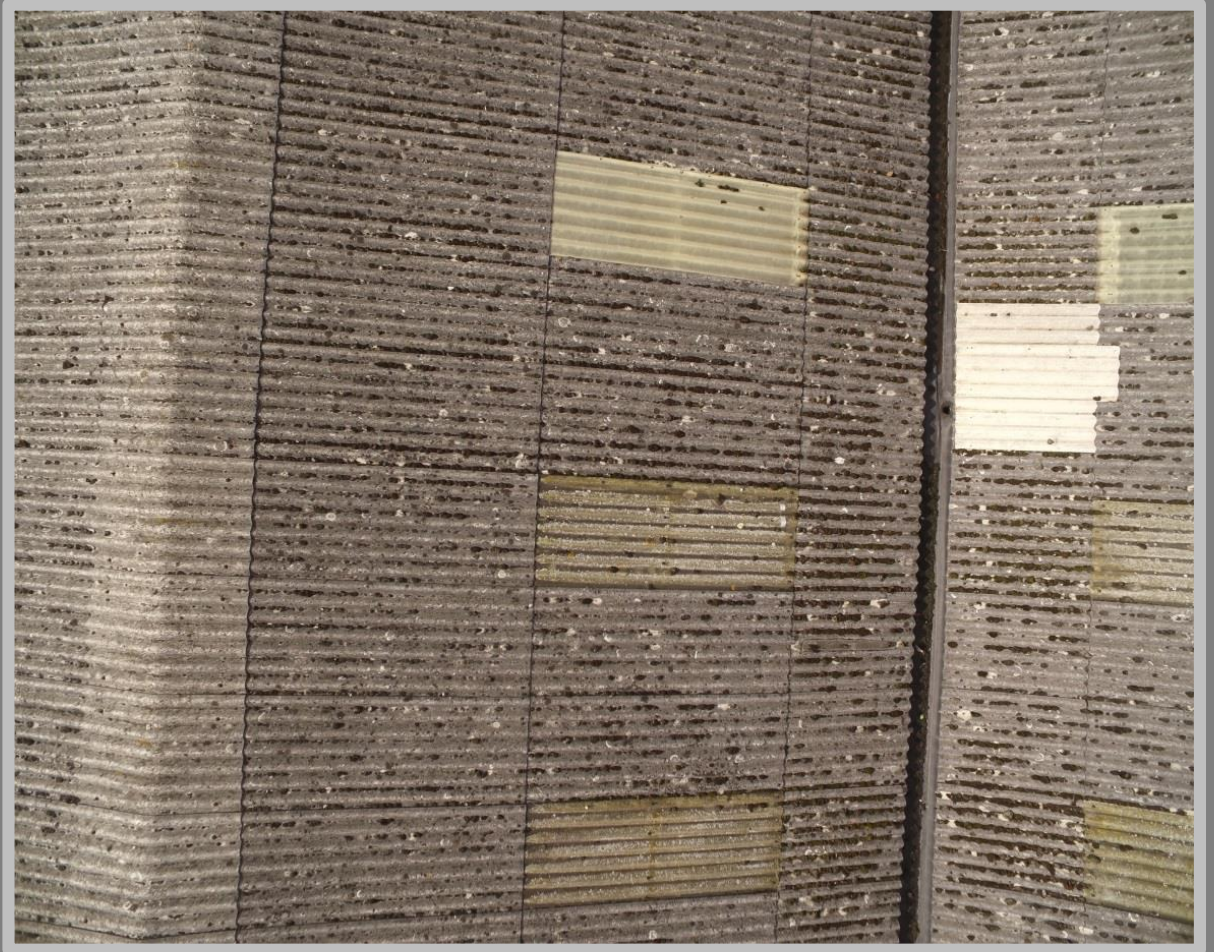
This shot typifies the whole roof's varying condition of roof-lights, widespread de-laminating and the need to apply patches to leaking roof panels.

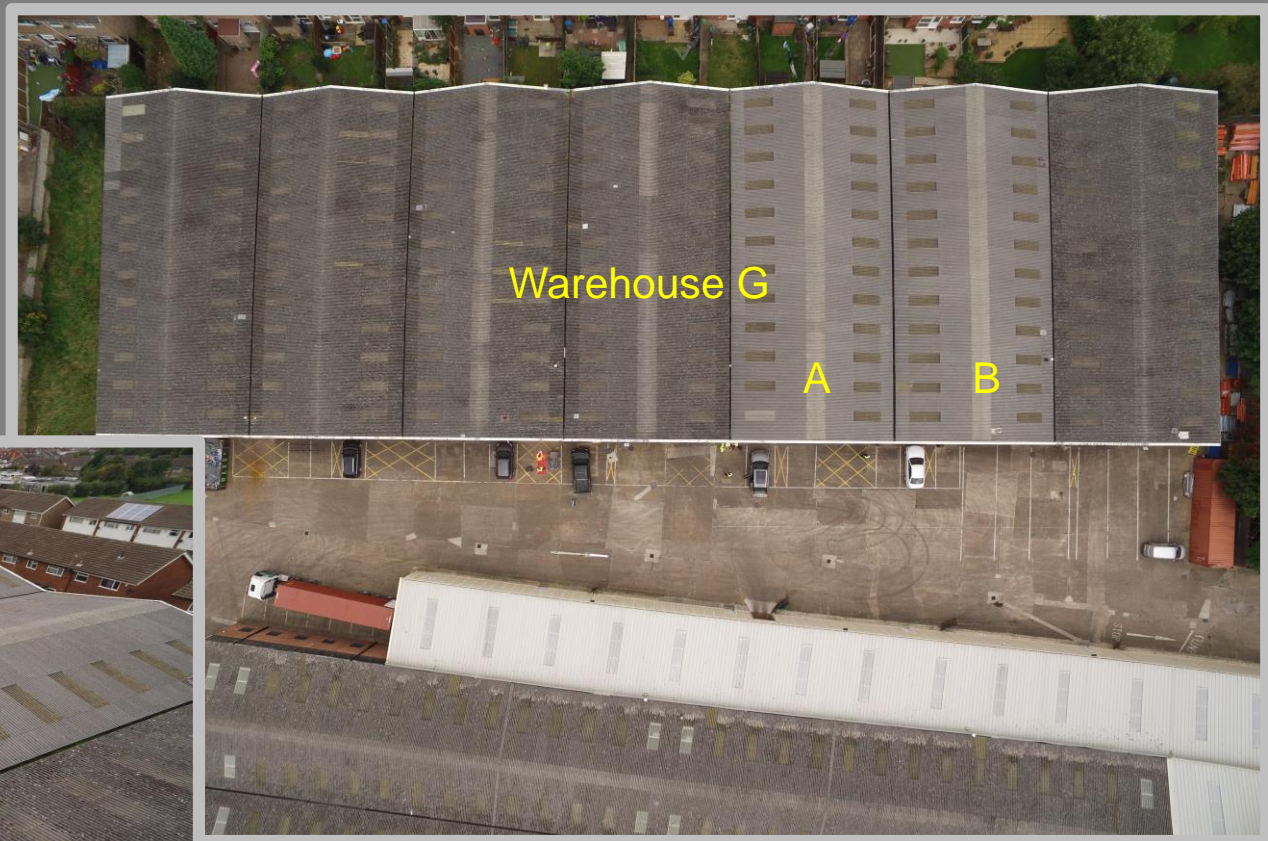
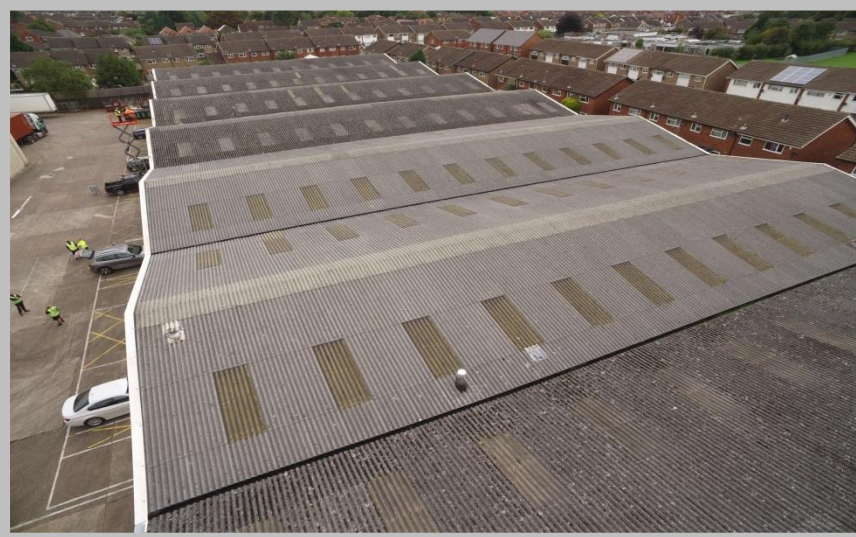
Screen grab showing moss and lichen condition for Warehouse G

From this direct overhead shot it can be seen that roof pitches A & B are in a more moss and lichen free state than the rest of the roof pitches. They have either been cleaned or are relatively recent replacements.

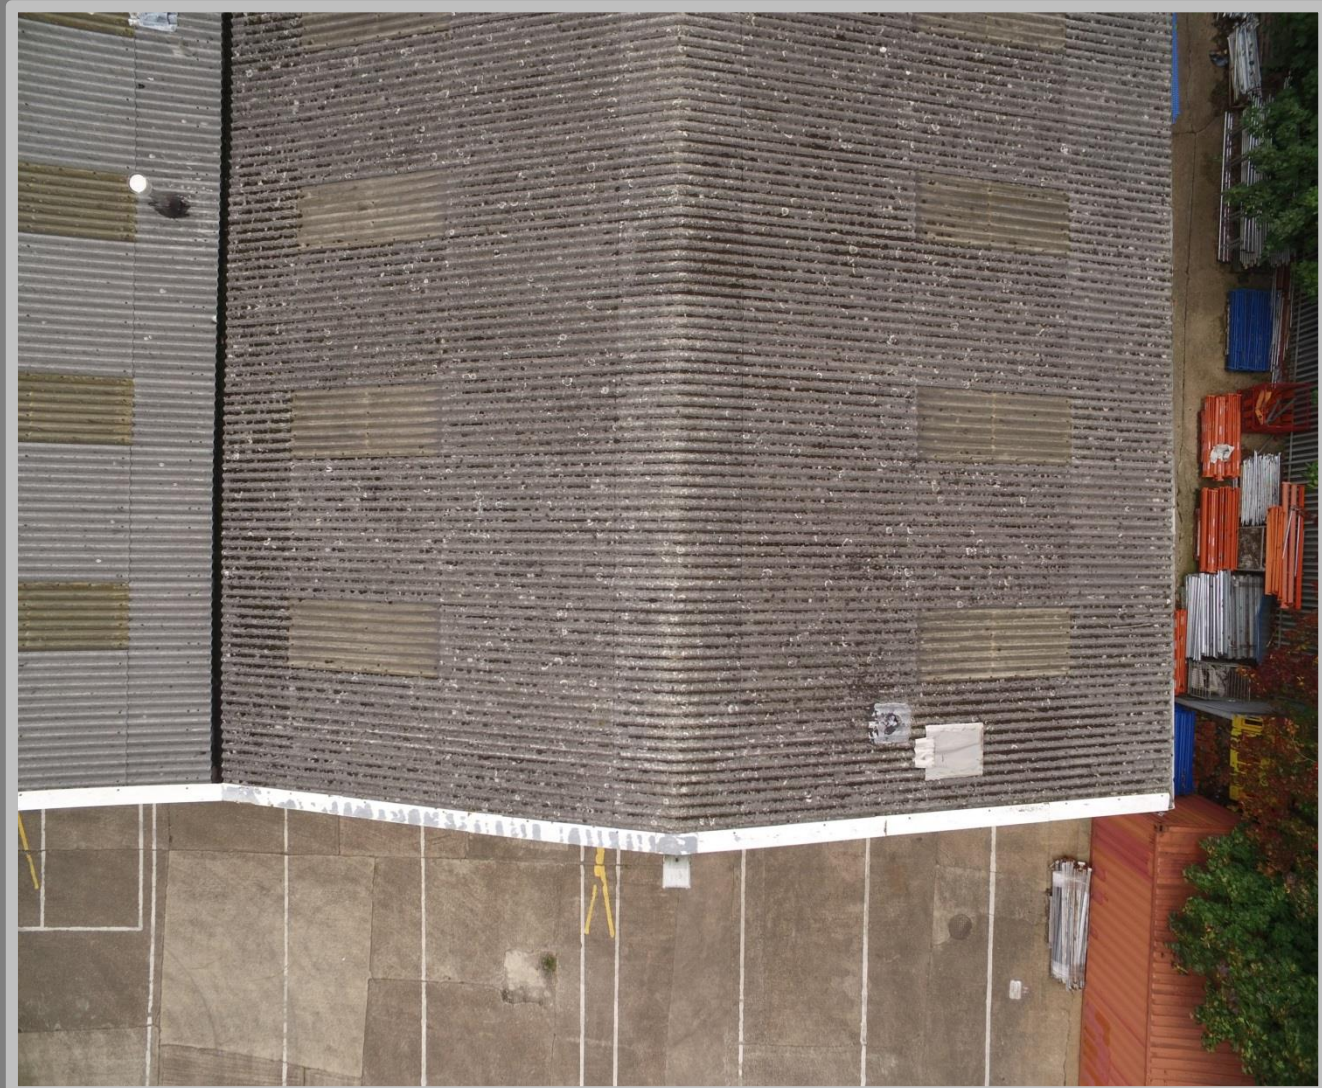
This shot shows the variation in the condition of the roof-lights. The shot is representational of the whole roof once again evidence of delamination throughout and lichen growth.

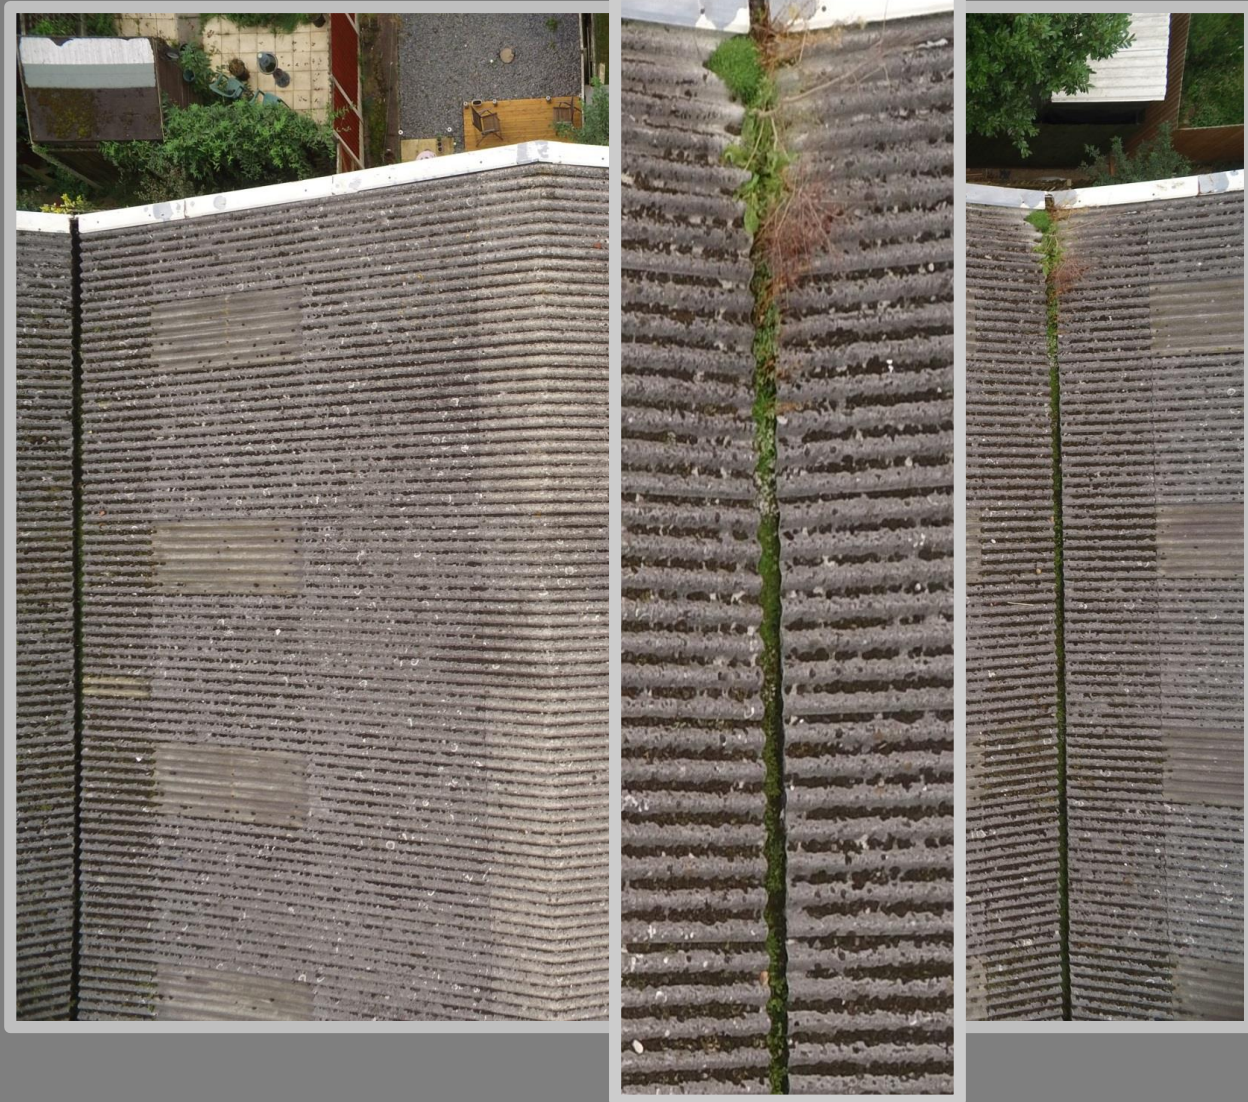
Valley cleaning & repair

As is prevalent on all of the roofs there is evidence of delamination.
