Long Eaton Aerial Survey 12 September 2017

Aerial Roof Survey

Aerial Roof Survey – Job Number 42669

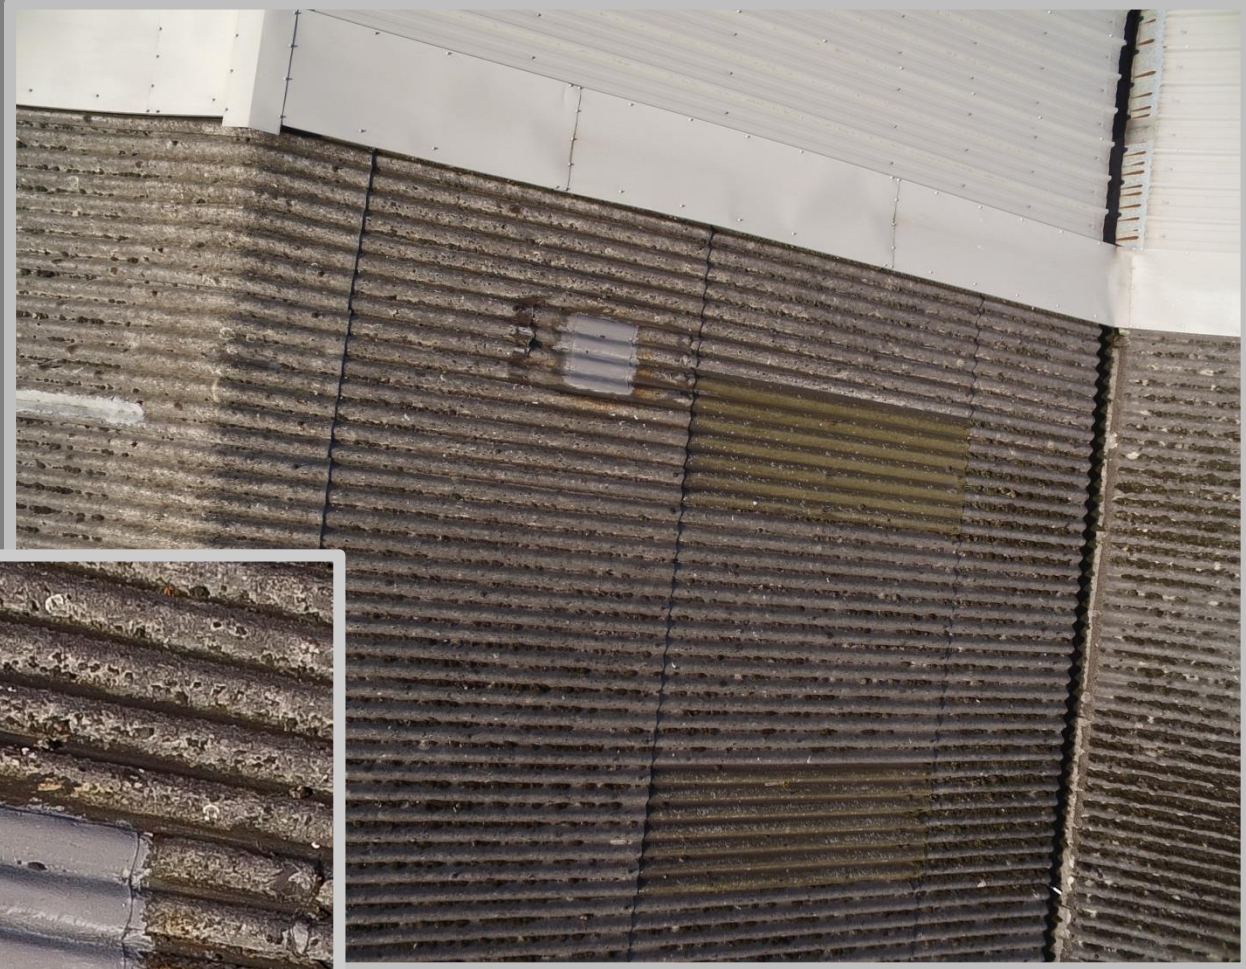
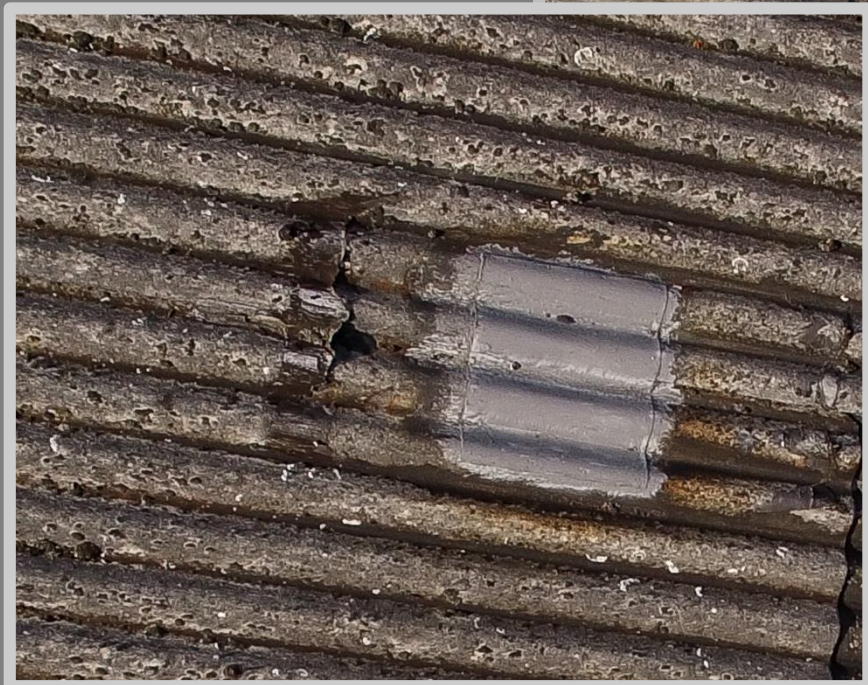
This aerial shot shows roof H and its join to the new roof. The join is sound however, as the asbestos cement deteriorates and cracks along this edge repair will prove problematic.

The close up of the patch repair once again shows the general condition of the roof and why frequent repairs have been necessary.

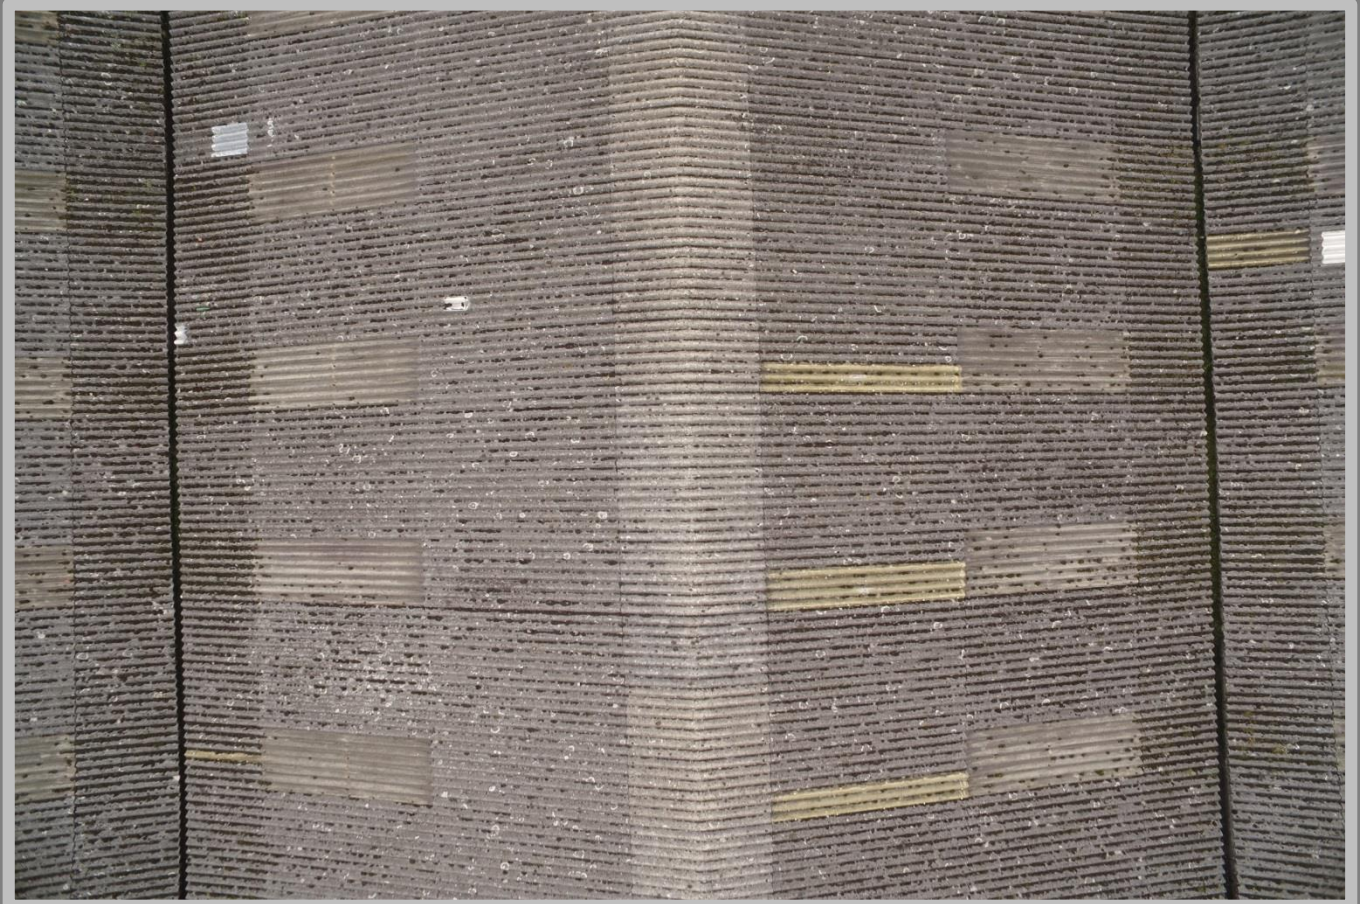
Existing Repairs

This shot shows that the roof has had a number of patches as stated previously this is an indication that the roof is becoming porous and brittle due to delamination.

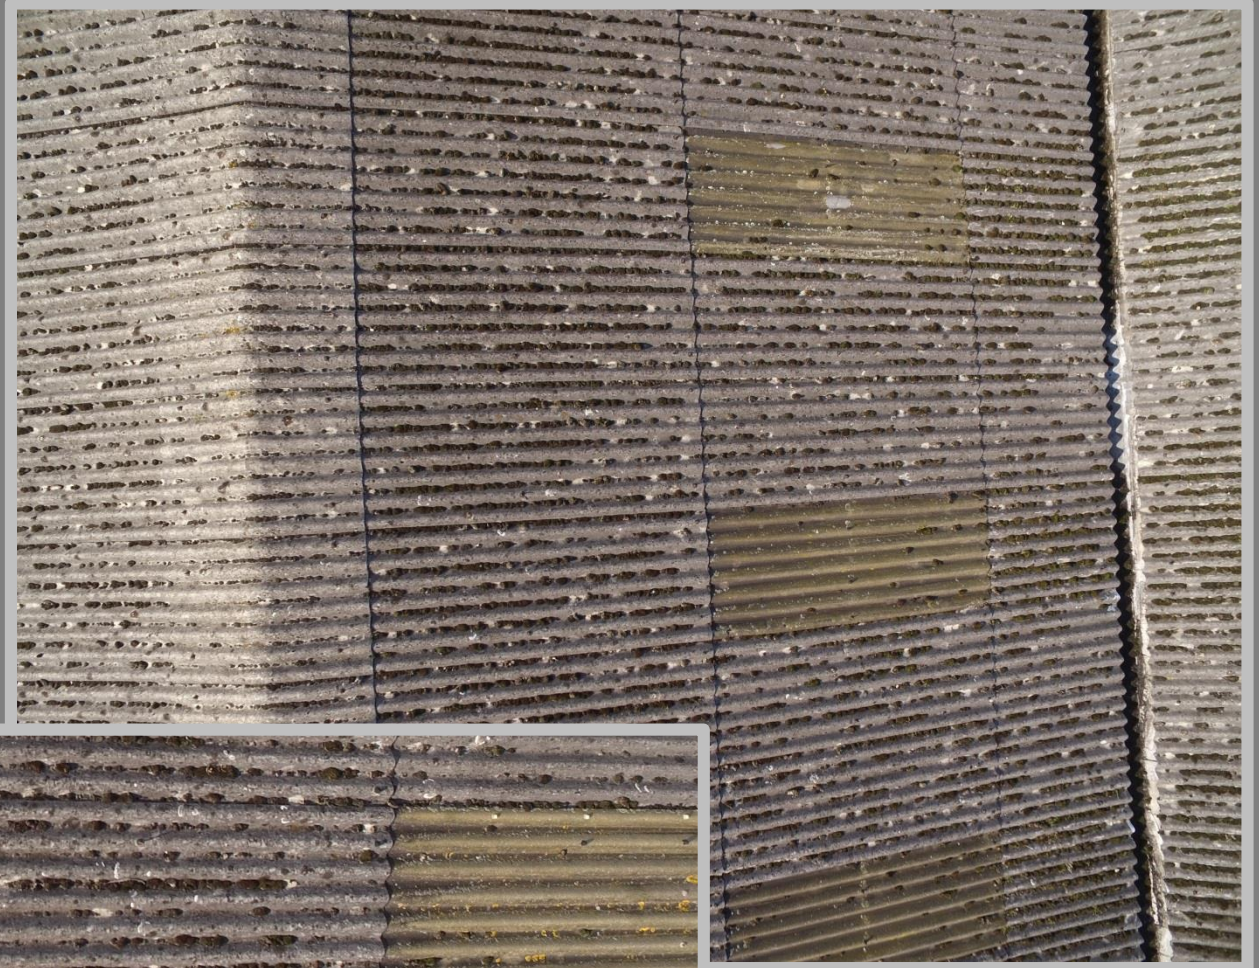
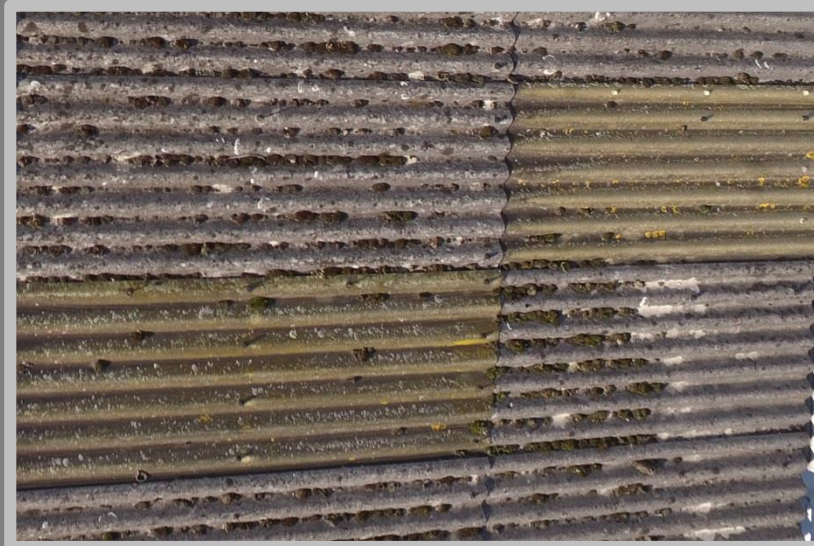
This shot shows the general condition of the roof-lights.

UV light will cause the roof-lights top resin coating and the sealant to degrade. Moss will also grow up and under the roof-lights allow water to enter past the degraded sealant via capillary action.

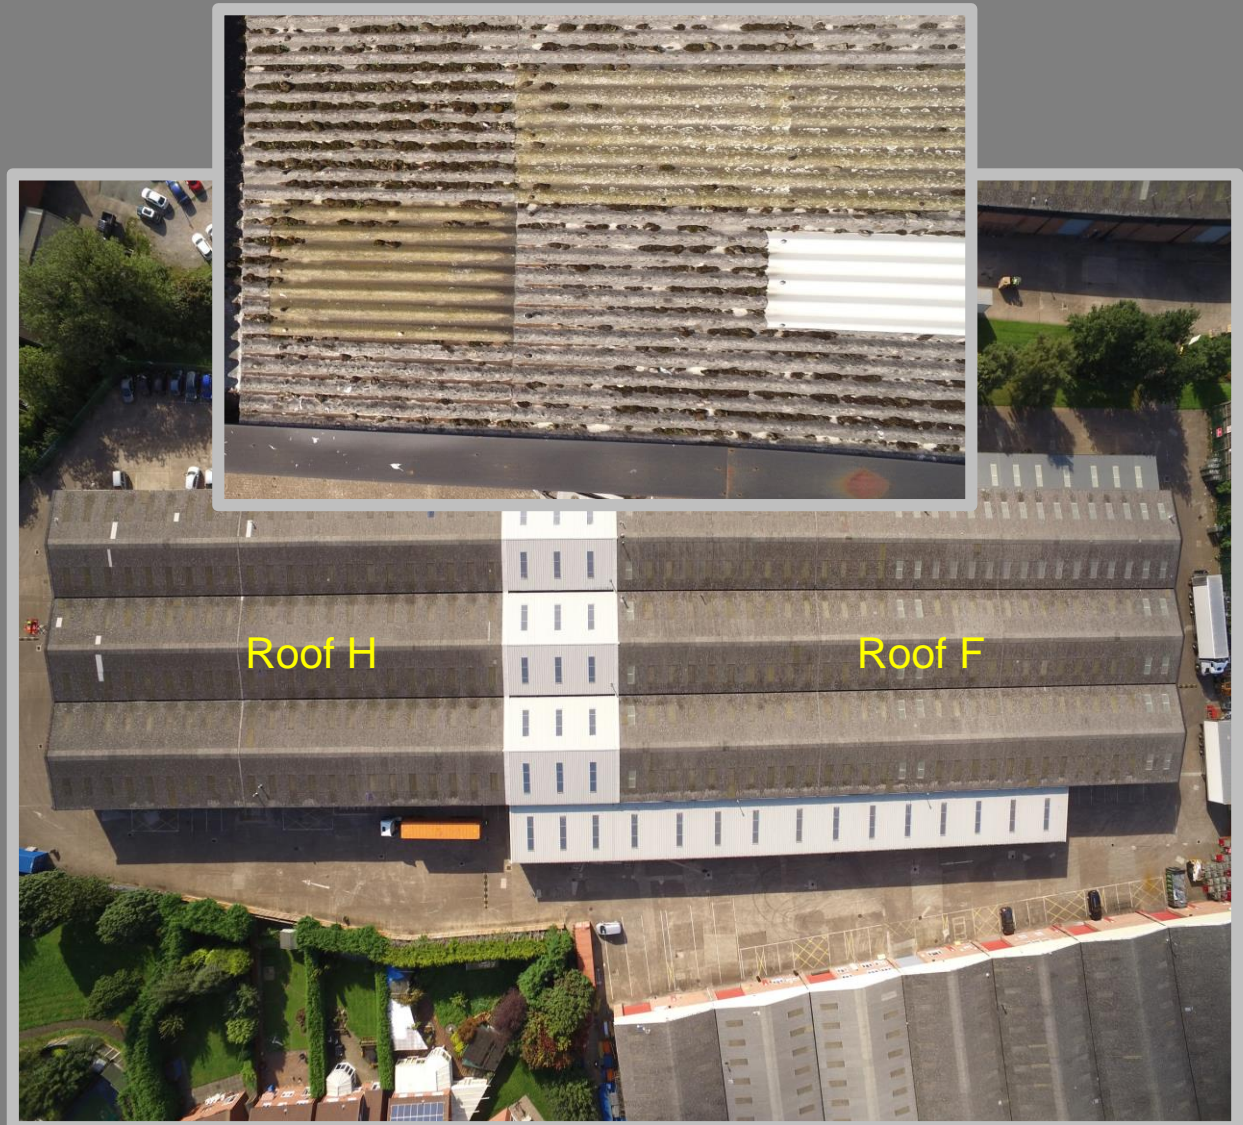
From this shot it can be seen that roof H has had a number of patch repairs applied.

The close-up shot shows the condition of the roof where once again deterioration of the asbestos cement has taken place over a period of years.

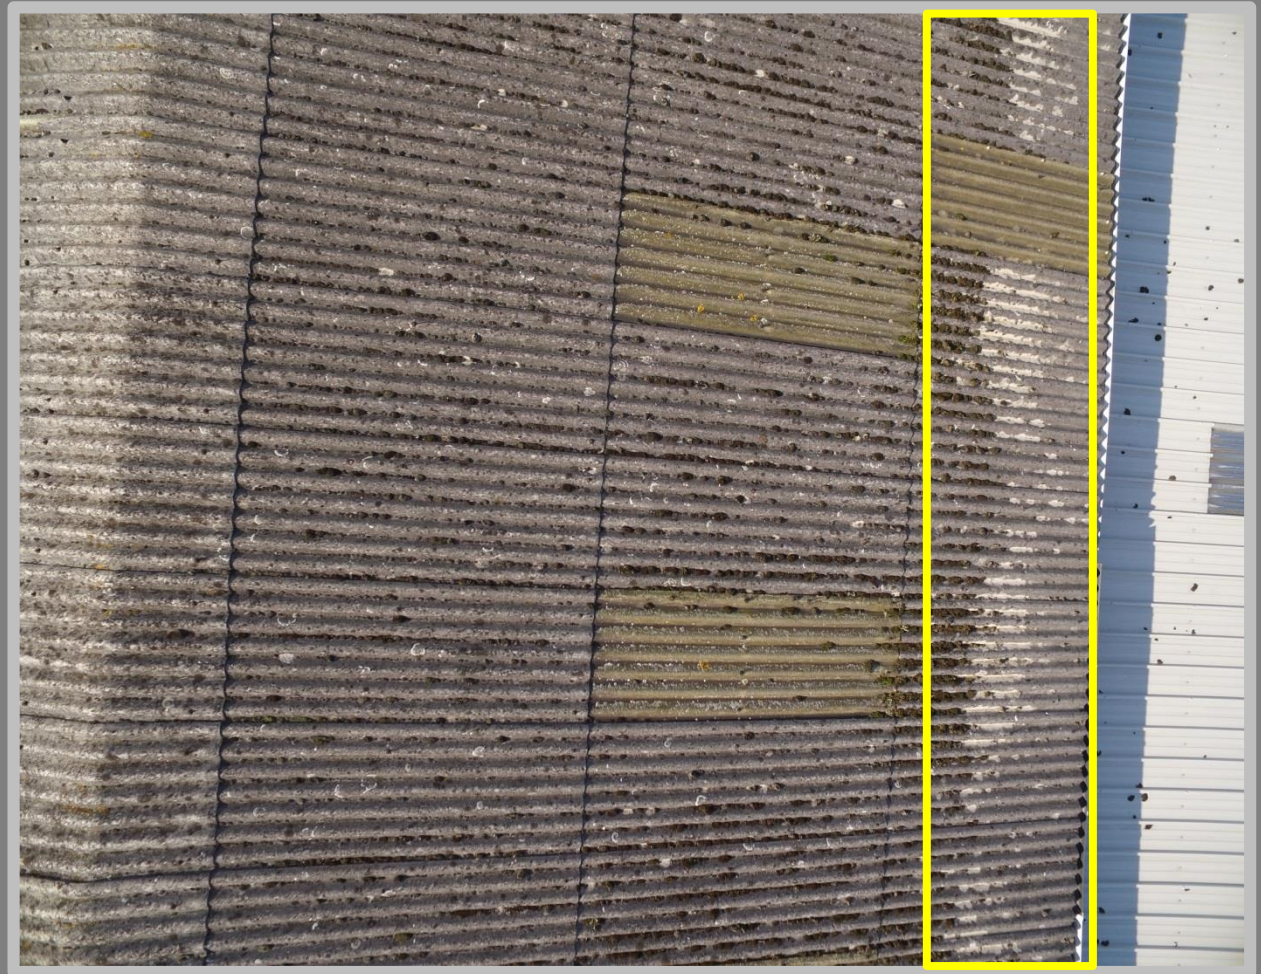
From this shot you can see delamination all along the bottom edge of the roof.

The roof will need to be completely cleaned. Work needs to be carried out to prepare bolts, cracks & de-laminated areas and encapsulate to prevent further delamination. This is a much cheaper option than re-roofing or over cladding. Over cladding also puts much more stress on the existing roof structure.

When roofs become porous and brittle they need encapsulating as soon as possible. A roof in this state can very quickly start cracking which moves the roof from a repair to a roof demolition and replacement. The cost incurred through demolition and asbestos disposal and business interruption can be very inhibitive. It is the classical case of a stitch in time! If the roofs are all repaired in the above stated manner this could add another 25 years to their functional life expectancy.

That you engage a roofing contractor to clean and encapsulate the roofs and to address the roof-lights at the same time. It is recommended that all roofs are repaired in this stated manner.
