Long Eaton Aerial Survey 12 September 2017

Aerial Roof Survey

Aerial Roof Survey – Job Number 42669

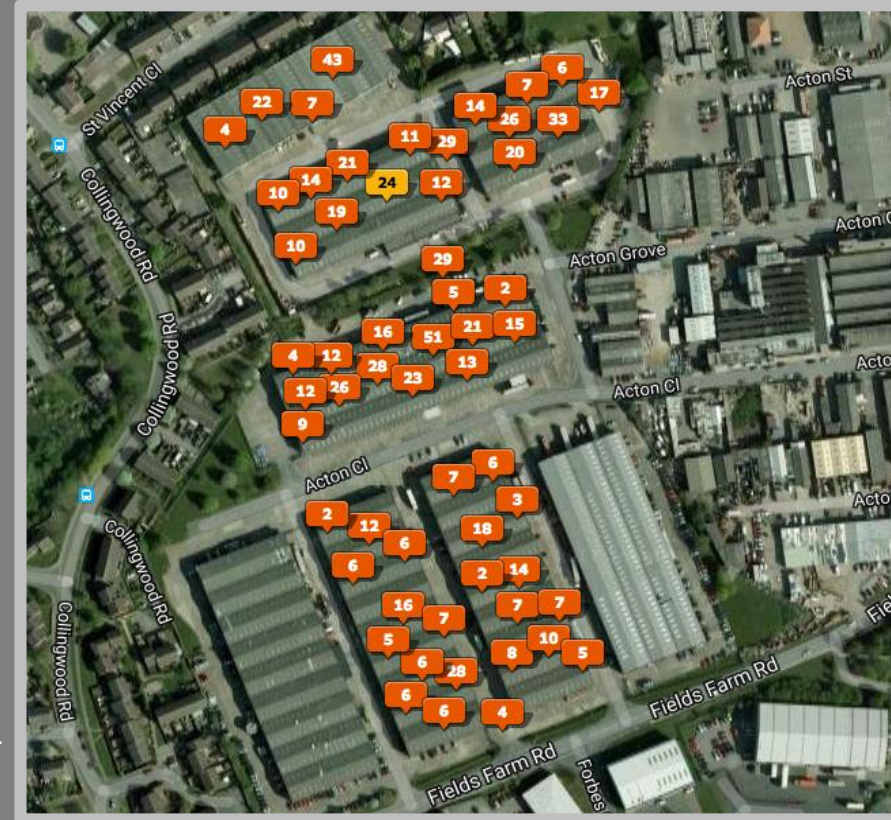
The roofs are all over 40 years of age and were all built within the same time period. From our examination of all the roofs we have concluded that they are all in the same deteriorated condition.

The overall condition of all the roofs is aged deterioration of the asbestos cement panels which has made them porous and brittle rendering them prone to cracking and leaking. Significant delamination is evident and consequently contributes to cracking and leaking.

The condition of the patches shows that the majority have been applied in the last 5 years indicating the universal deterioration of all the roofs in the last 5 years. All the roofs are now very porous and brittle and therefore will progressively fail over the next five years. This could be accelerated with hard frosts and heavy snow coverage.

Because of the overall condition of the roofs there is no obvious priority from a condition score but we are advised that G&H roofs leak into the warehouse below and therefore would be given priority.

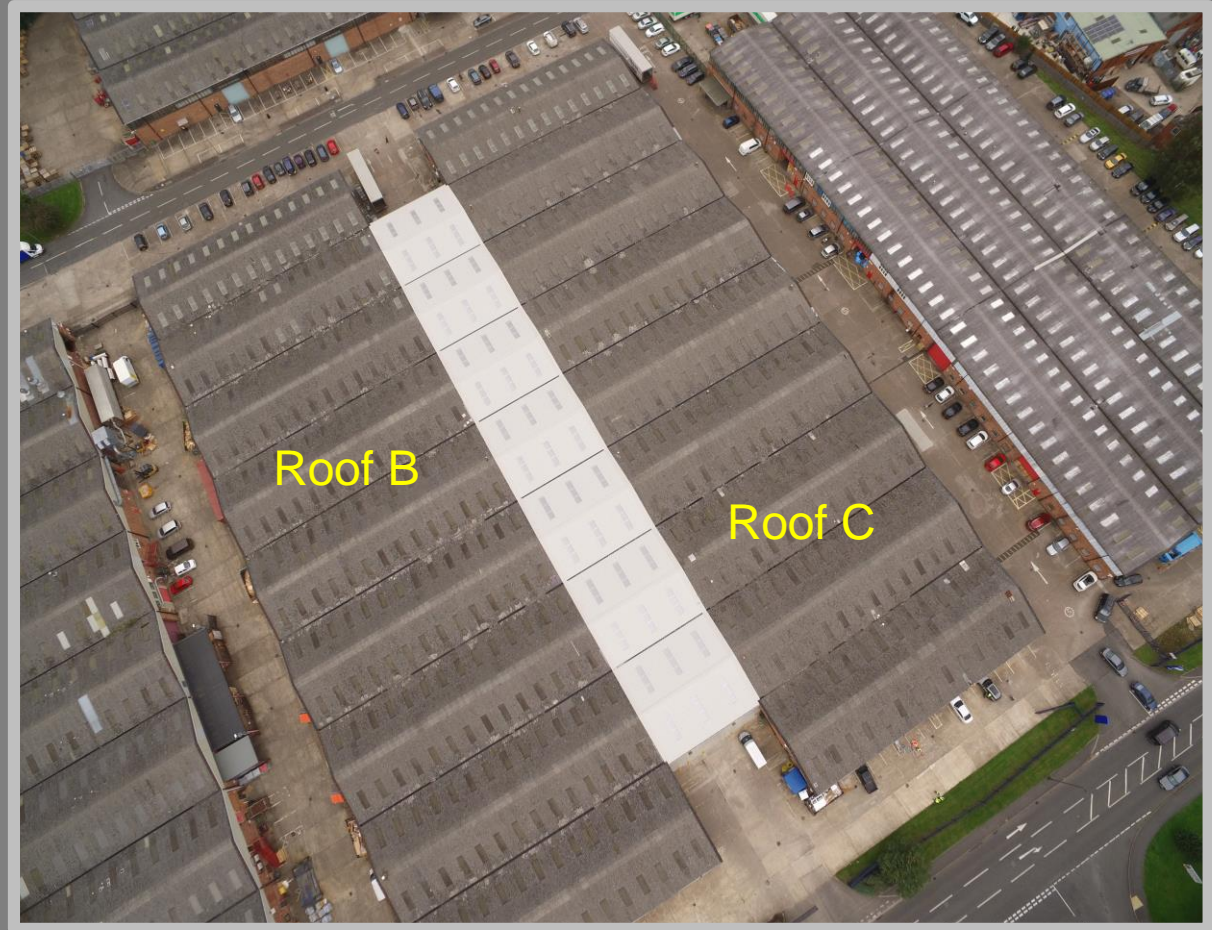
From this shot it can be seen that each roof comprises of 9 pitched asbestos cement roofs. The roofs have 8 valley gutters which have been inspected for damage and to make sure they are not blocked.

The roofs have also got many roof-lights which have been inspected for condition and damage.

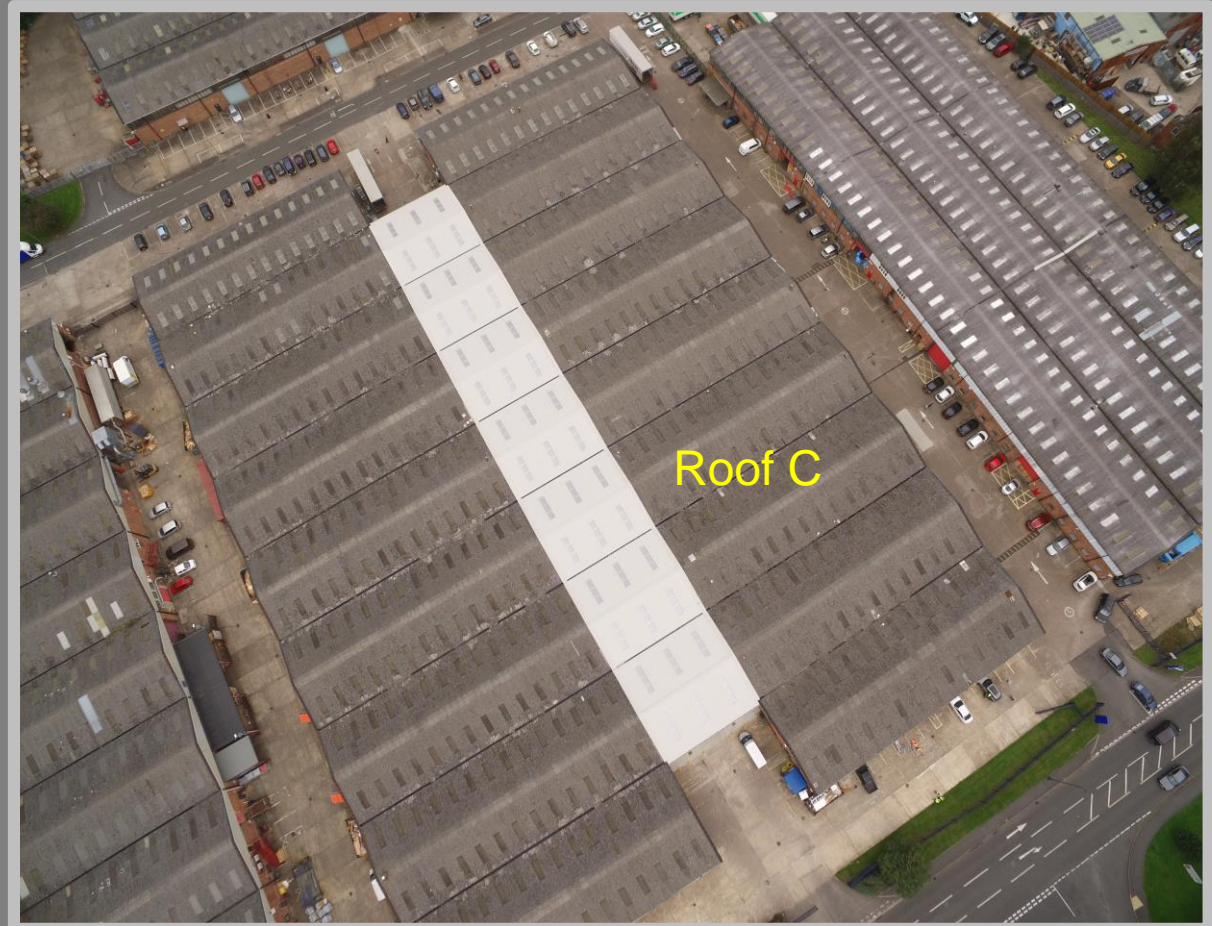
From this shot it can be seen that the roof comprises of 9 pitched asbestos cement roofs. The roof has 8 valley gutters which have been inspected for damage and to make sure they are not blocked.

Roof C is comprised of 9 pitched roofs each pitched roof has 28 roof-lights. Roof C has a total of 252 roof-lights.

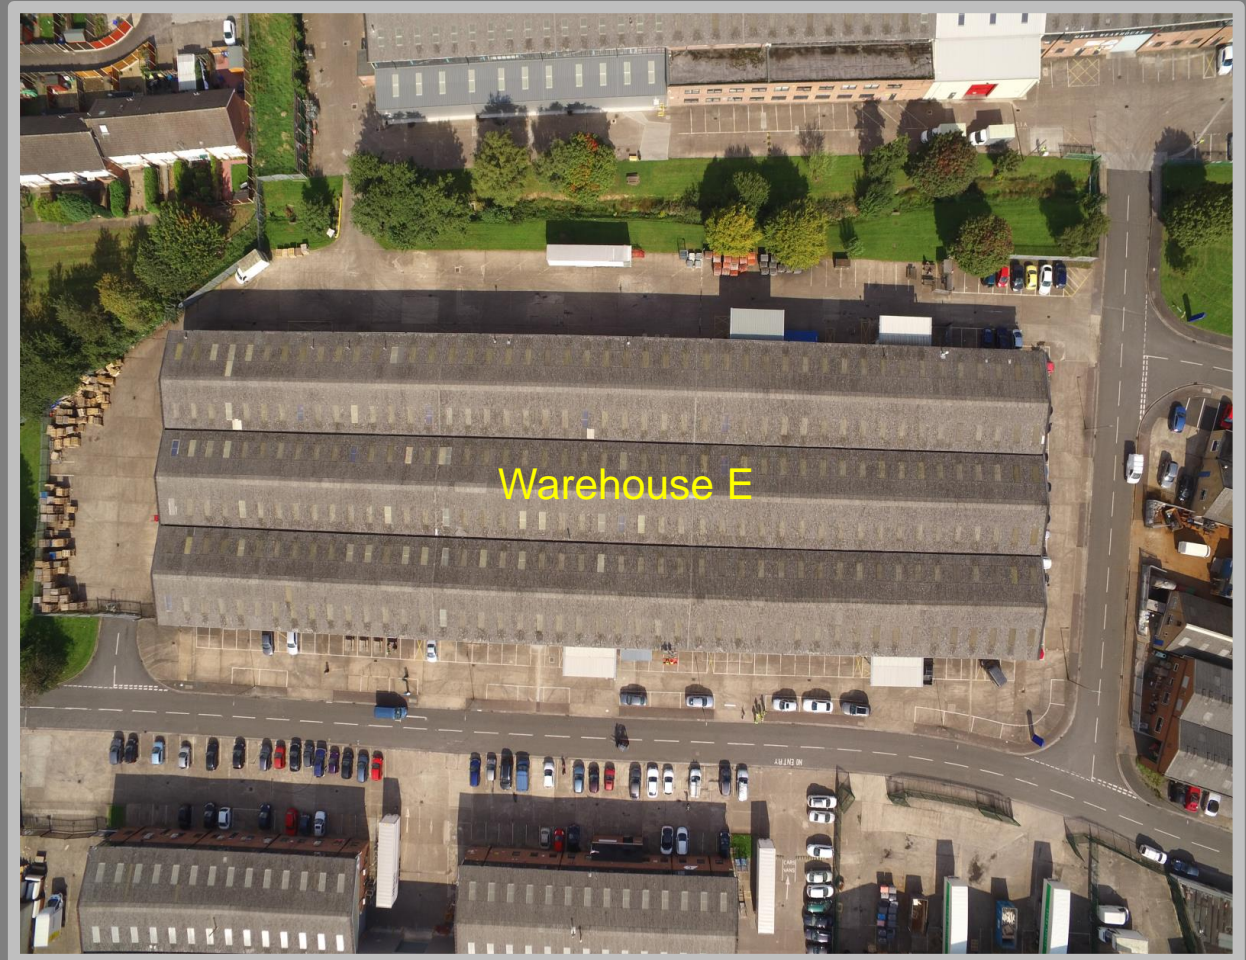
This aerial shot shows the roof of Warehouse E.

From this shot it can be seen that the roof comprises of 3 pitched asbestos cement roofs. The roof has 2 valley gutters which have been inspected for damage and to make sure they are not blocked.

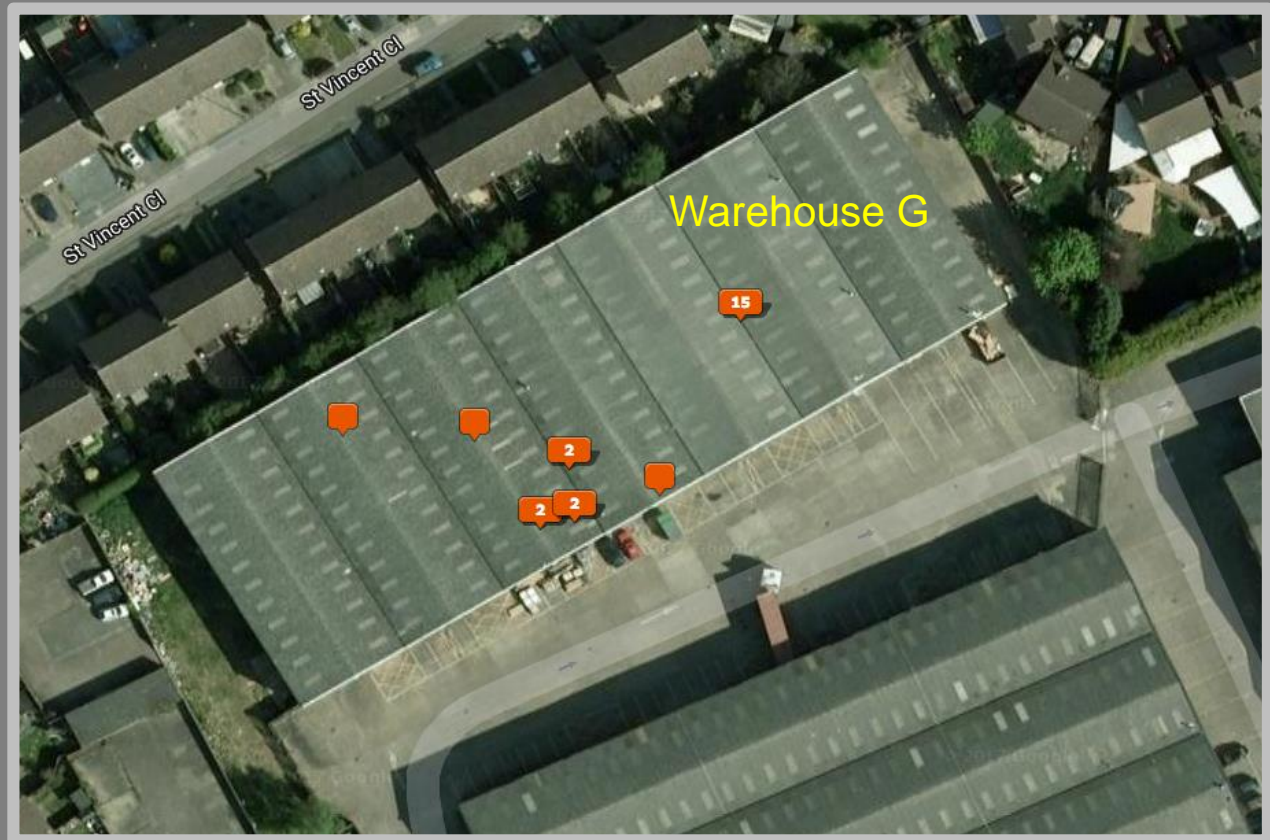
Screen grab showing moss and lichen condition for Warehouse G

From this direct overhead shot it can be seen that roof pitches A & B are in a more moss and lichen free state than the rest of the roof pitches. They have either been cleaned or are relatively recent replacements.

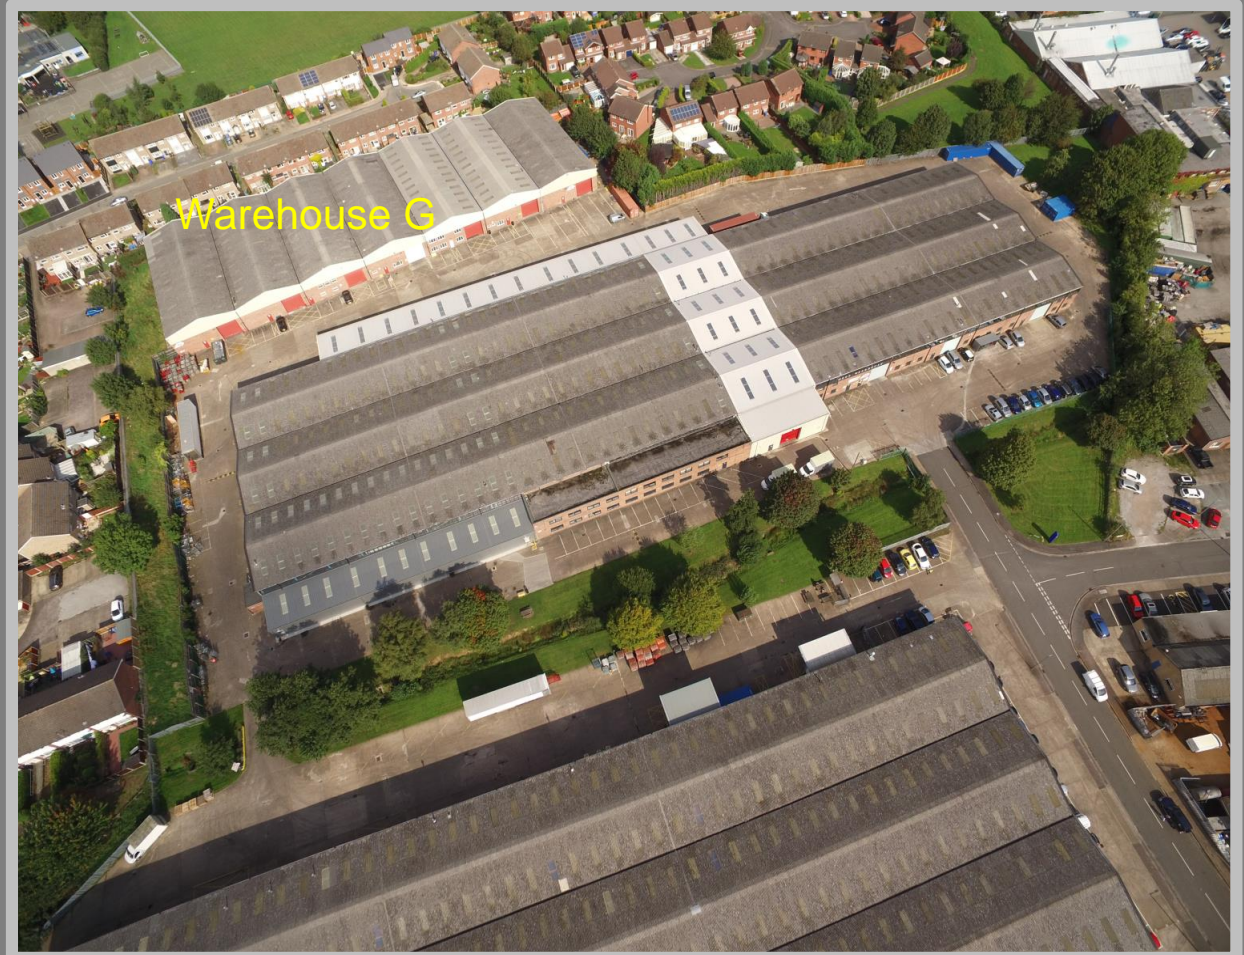
From this shot it can be seen that the roof comprises of 7 pitched asbestos cement roofs. The roof has 6 valley gutters which have to be inspected for damage and to make sure they are not blocked.

The roof has also got many roof-lights which have been inspected for damage.

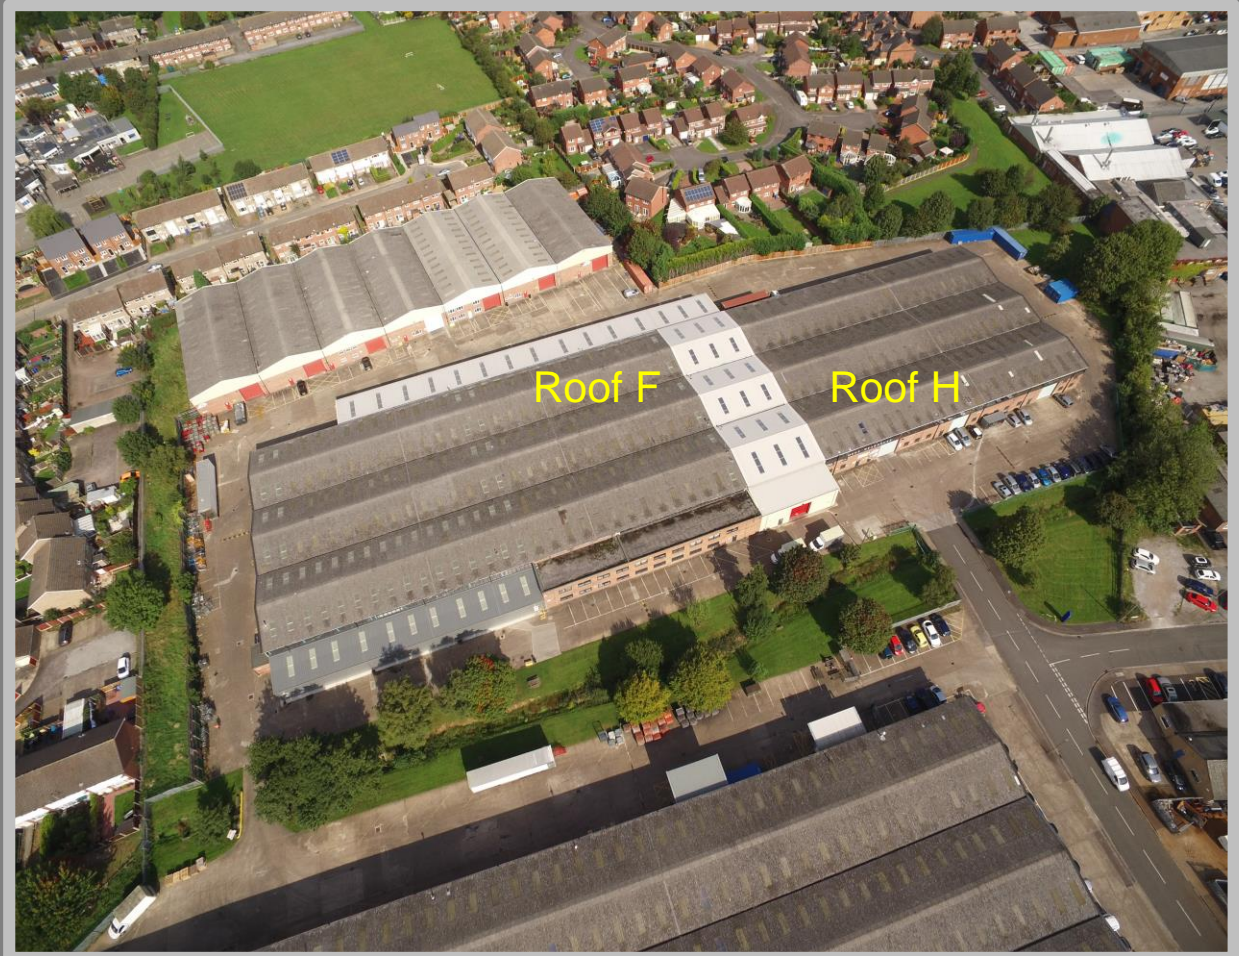
From this shot it can be seen that both of the roofs comprise 3 pitched asbestos cement roofs. Each roof has 2 valley gutters which have been inspected for damage and to make sure they are not blocked.

The roof has also got many roof-lights which all need to be inspected for damage.
